Reading Memorial High School Feasibility Study

*A Study Proposing Physical Improvements
to Support the Educational Goals of the
Town of Reading, Massachusetts*

February 21, 1997

Drummey Rosane Anderson Inc.
Architecture & Interior Design

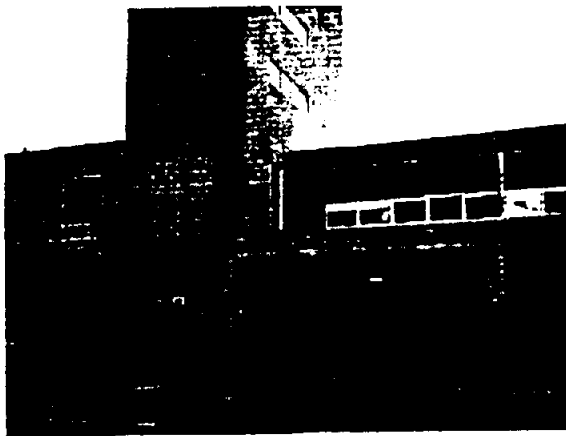
Main Entrance

The Girl's Gym entrance canopy and lobby roof and the main entry canopy roof all hold water. This was observed after a week of rain and melting snow. While no interior damage was observed, there was some deterioration of the concrete cap and fascia at the main entry.

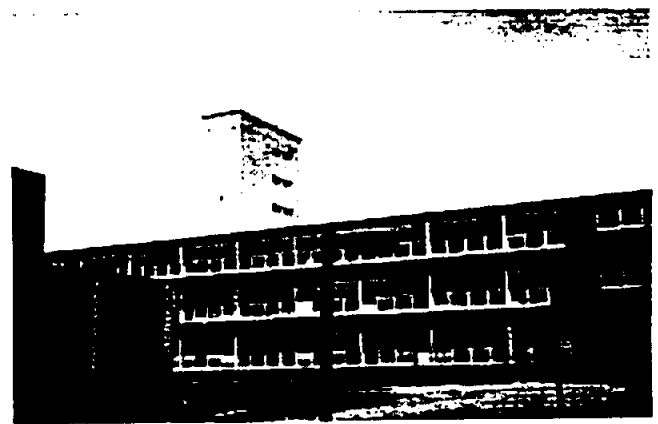
Exterior: The brick, windows, glass block, sills, foundation, and coping are all in generally good condition, although many areas have aged and need attention.

Exterior Elevation

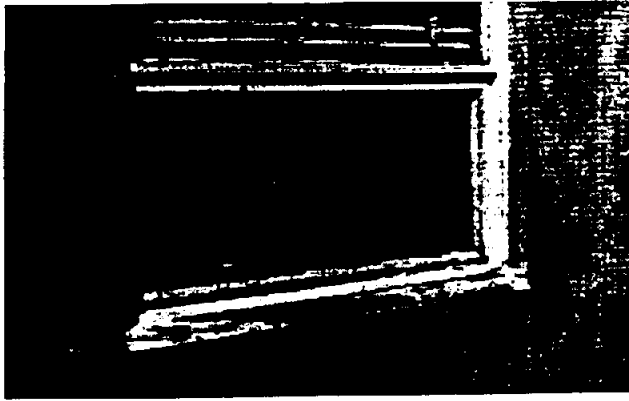
The window system is a combination of steel sash with outward-projecting windows, and glass block. The windows are single glazed and are not energy efficient. The windows at the Pupil Personnel offices and the Kitchen director's office are badly rusted and the steel sash is deteriorating.

This is also true of the windows and the metal panels in the window system of the Science Building, (Building C). The sealant is weathered and cracked. It is recommended that the entire window system be replaced with double-glazed

Rusting Window Sill

windows in all buildings except the Field House. This would not only cut down on the maintenance, but, in combination with an overhaul of the heating system, would save energy and make the environment in the rooms more comfortable. The peeling paint on the lintels and columns between windows probably contains lead, and should be abated when the windows are replaced.

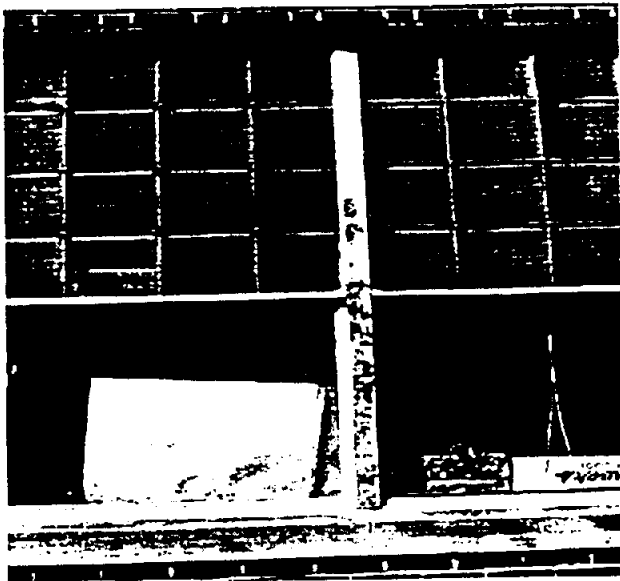
Deteriorating Window Sill and Jamb

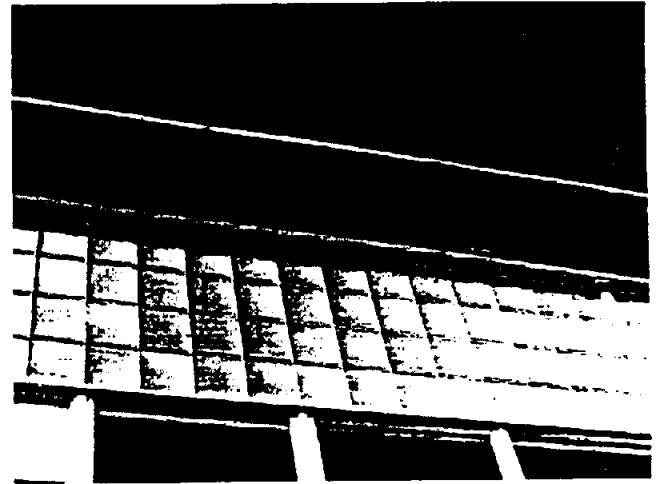
The concrete eave which surrounds most of the building has exposed, rusted reinforcing bar. It needs to be determined whether the past roof leakage is to blame (most likely) or a design flaw of the eave which must be addressed. Regardless, the eave should be repaired to prevent further

deterioration. As was mentioned earlier, water dripping off the two front entrance canopies is causing deterioration of the concrete fascia. This appears to be because of a negative slope to the roof drain.

Concrete fascia showing rusting reinforcing

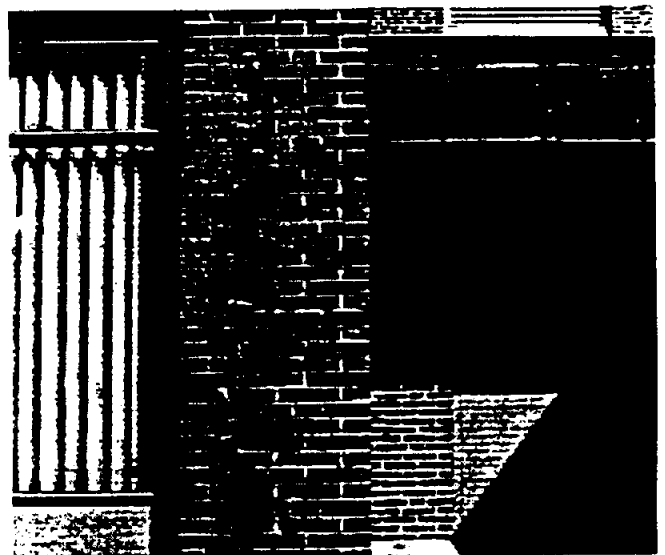
There is considerable mortar missing from the brick wall adjacent to the back Kitchen entry. It looks like old damage which was halted when the roof was replaced. However, the bricks must be repointed. Also, many control joints are missing sealant and backer rods. There are no apparent weep holes in the brick-face walls of the 1952 school.

Masonry in need of repair.

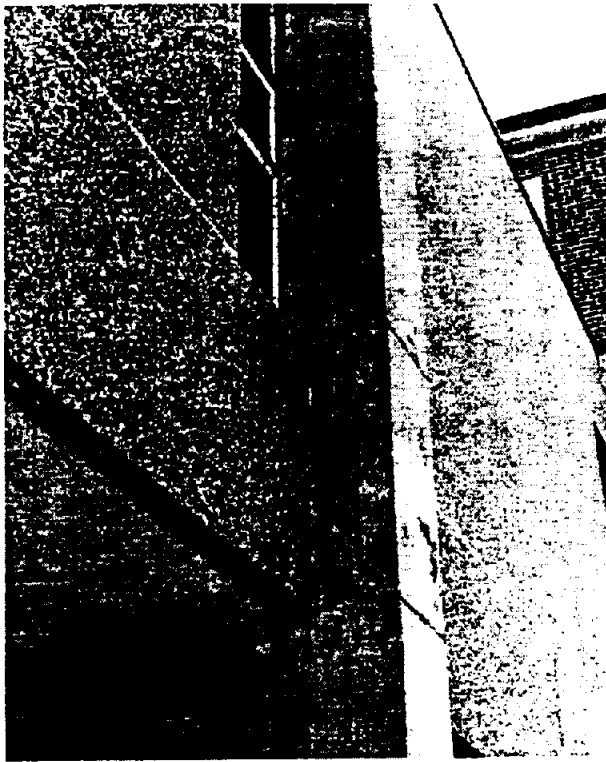
1. The extreme temperature differential between the inside and outside surfaces of the columns is causing the steel columns to expand and contract. The concrete casing around the columns cannot expand and contract to such extremes.
2. The steel columns are surrounded by massive amounts of concrete - up to four feet. This is confining the steel and forcing the concrete to do some structural "work", which it was not designed to do.

3. These columns may have been poured in the winter. An "accelerator" may have been added to the concrete to speed up curing time. This accelerator may be leaching through the concrete,

Steel and concrete columns of a corridor bridge.

showing up as efflorescence on the exterior. As the salts and minerals migrate through the concrete they attack the steel reinforcing, weakening it.

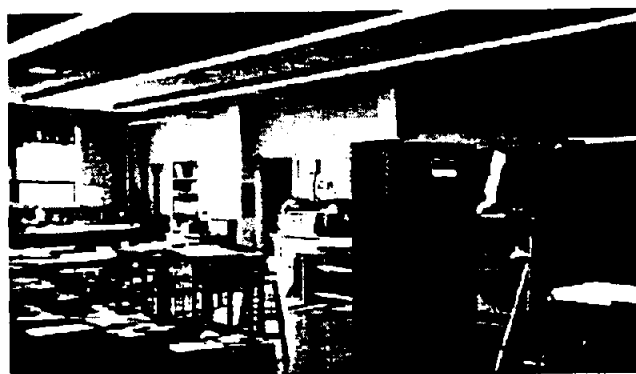
Art Studio / Industrial Arts.

The Industrial Arts Building layout is confusing, with dead-end corridors and lots of tiny, locked rooms. The art rooms, while spacious, are at the end of a maze of "dead-end" hallways and small rooms, making emergency egress potentially dangerous. The CADD classroom has spilled out into what should be a corridor, creating a narrow, dark CADD annex. (By code, a hallway cannot be longer than 20' without a direct means of egress such as doors to the outside, or a stair which leads to an exit. Although end rooms in this wing have exterior doors, these can only be used by students in these rooms. Students in adjacent rooms or hallways are thus in a "dead-end", requiring backtracking to an approved exit or exit corridor.)

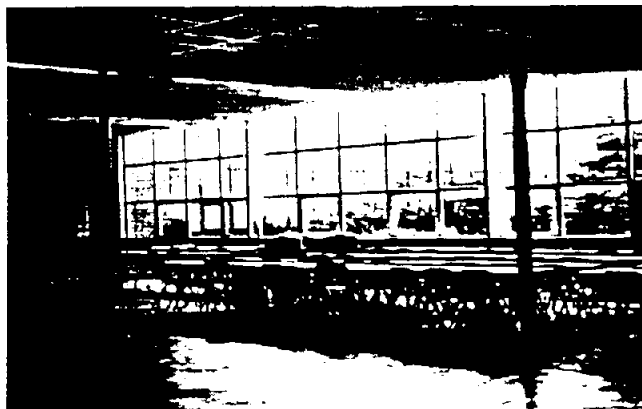
The Cafeteria is in good condition, although it is underutilized. Perhaps a vending machine zone or lounge could be inserted to "zone" the space and encourage more efficient use. If the connecting corridor at the back of the Commons is redesigned, perhaps it can provide a view out of the cafeteria and through the courtyard.

Cafeteria

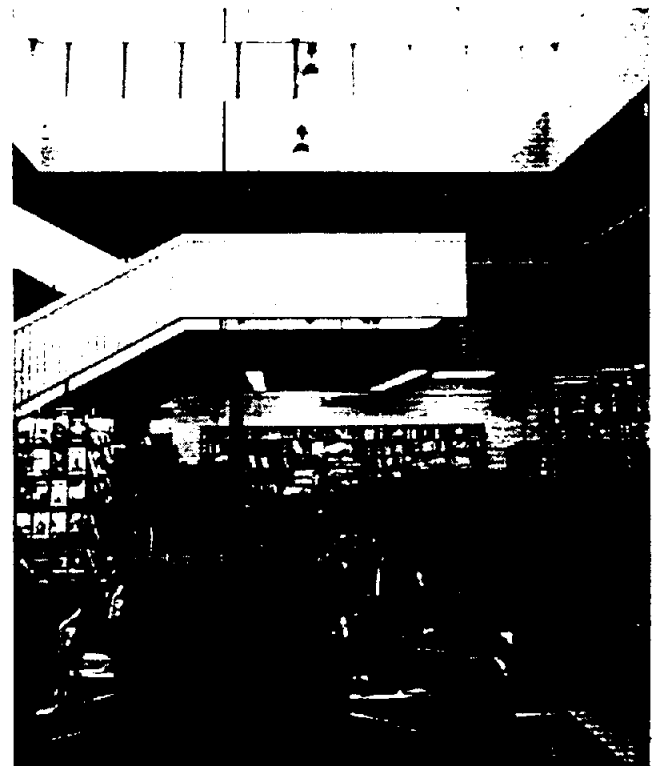
The Information Resource Center has some nice qualities, such as the openness and the quality of light. However, the layout is not conducive to supervision of students on the upper level, and a

Information Resource Center.

large amount of space is wasted. Consequently, the second floor is rarely used. Compounding the problem is the lack of accessibility to the second floor. While restricted access does help with vandalism, there is no connection from here to the rest of the school. It is recommended that an elevator be installed to make the second and ground floors of Building B accessible. It is also recommended that the classrooms on the second floor be remodeled to meet classroom size standards, and be utilized to assist with supervision to this floor.

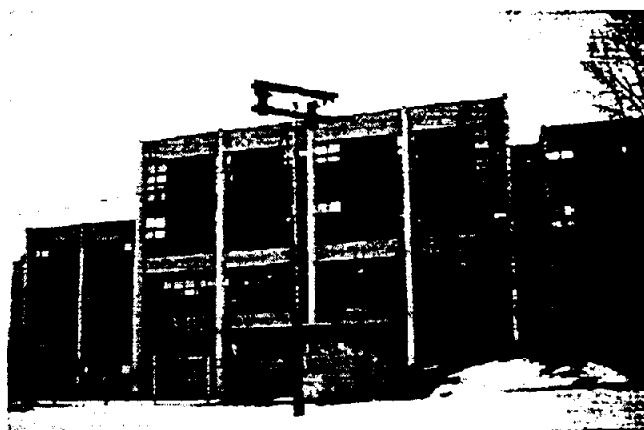
The Science Building has undergone several renovations since it was built in the 1960's. The result is large lab rooms and adequately sized classrooms. However, there are also an extravagant amount of teacher planning spaces and specialized labs. The west-facing classrooms also have an uncomfortable amount of solar gain. The acrylic single-glazed windows offer no energy resistance and have yellowed. These should be replaced with a double-glazed thermo-pane system.

West-facing elevation of Science Building.

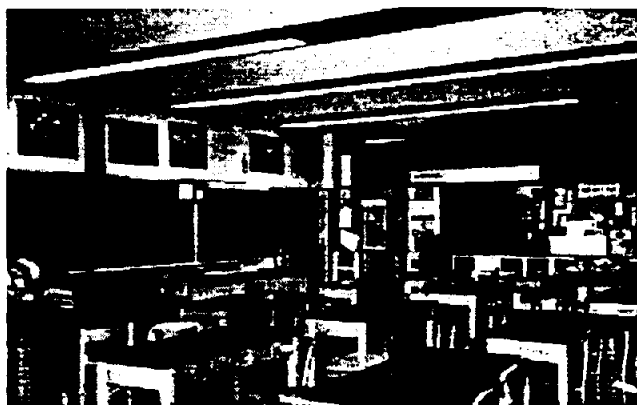
The desks and lab tables all need to be refurbished. Safety and Lab equipment should be inventoried and updated. Refer to the Furniture and Equipment Report for more details.

Typical General Science classroom.

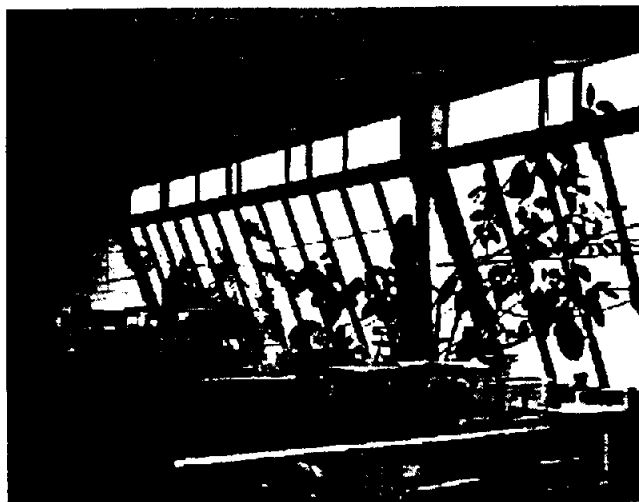
The layout of the Science Rooms, corridors and labs are unsatisfactory and inefficient. The ratio of teacher offices and storage to classrooms is high. The Vivarium needs an upgraded ventilation system and some sun protection.

Vivarium
