# READING MEMORIAL HIGH SCHOOL REVIEW OF EXISTING CONDITIONS

8 OCTOBER 2002

The Town of Reading School Building Committee, through Flansburgh Associates, Inc., is studying the Reading Memorial High School. In addition to examining the building's capacity and program functions, this study considers the quality and anticipated life of the physical plant. The existing conditions report is the first phase of the overall study; it provides a description and analysis of the building's materials and systems. Athletic fields and site features are also addressed. The report documents ongoing, and anticipated, maintenance/repair concerns. In most cases, this report does not propose a solution. It documents the existing condition. Solutions are considered in proposals made during the ongoing study.

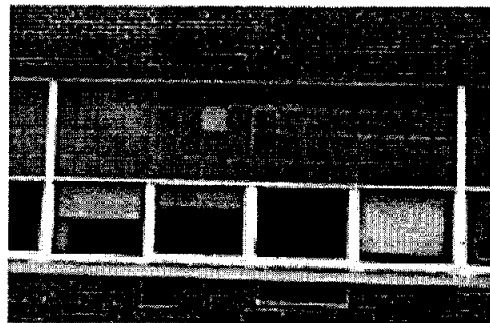
Previous research indicates that any attempt to upgrade this era steel window costs as much as a total replacement. Further, the structural engineer has noted significant lateral bracing concerns for the brick spandrels below the windows. This is similar to an unbraced parapet condition. See page III 25, part c.

Typical 1952 window system with glass block and steel frames.

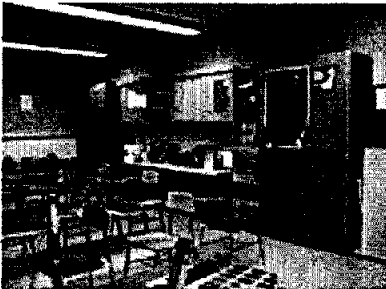
*Health Classroom*

The casework in this room is in very good condition.

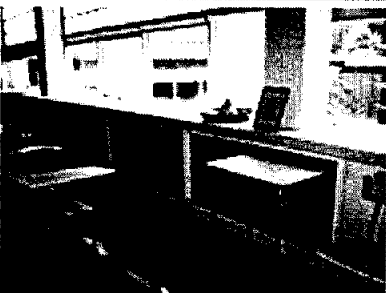
*Non-typical U.V. Condition in a Regular Classroom*

In some of the classrooms renovated in 1969, wood doors were added to the U.V. cabinets along window walls. Only those in good condition can be salvaged. Those that show signs of water damage or are beneath water damaged window sills cannot be saved.

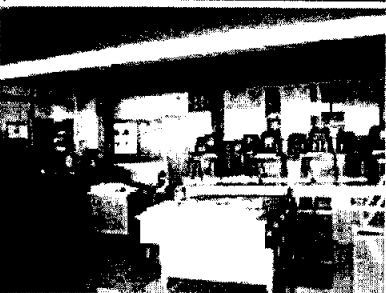
*Art Classroom #A121 Art*

In this room, the existing casework on the south and east walls is in good condition. New counter tops are recommended.

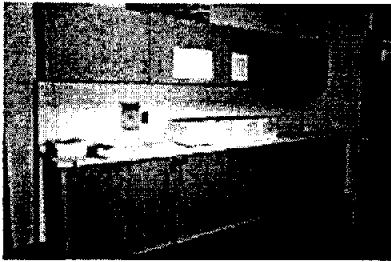
*Yearbook Classroom #203*

The casework in this classroom is in good condition, however it does not comply with ADA requirements. It can be used as storage.

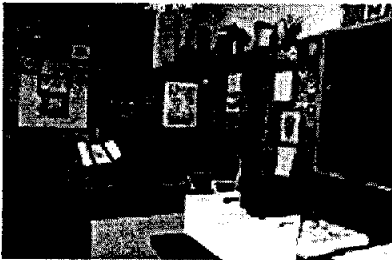
*Millwork Wall - Science Room (typical)*

This millwork wall will remain, however the hardware will require replacement in order for the cabinets to be lockable.

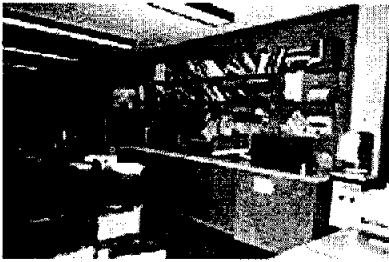
*Teacher Workroom*

This casework assembly is in good condition and may remain, although it is not accessible.

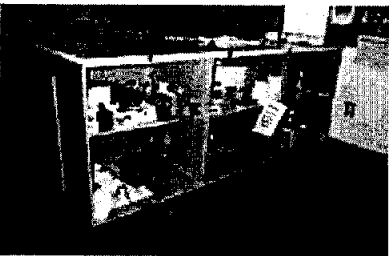
*Reception Office Desk*

This casework does not comply with ADA requirements and therefore can not continue to be used as a reception desk. However, it can be moved to another location and used for storage.

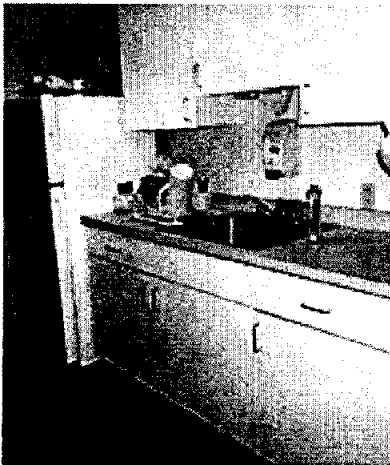
*Superintendent's Office Kitchen*

This cabinet assembly is in good condition, however it is not accessible and must be made ADA compliant.

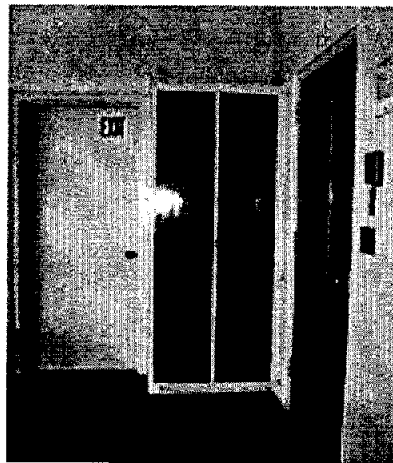
*Classroom Wardrobe (typical)*

The teacher wardrobes in the 1969 addition can be reused, however some shelf alterations and door replacements are recommended. All teacher wardrobes in the 1952 classrooms must be replaced.

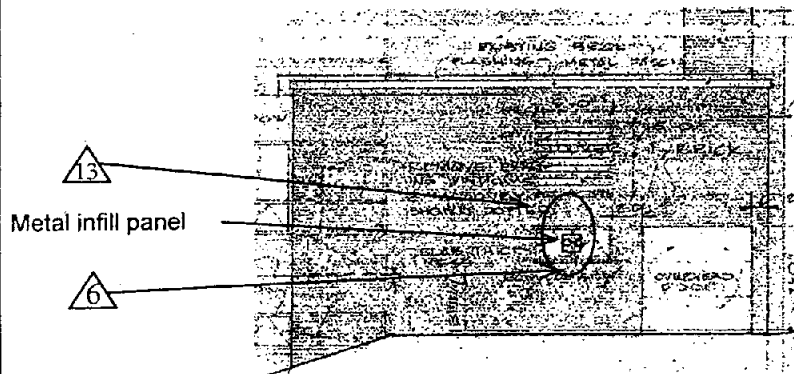
West Elevation / Seg. A<sub>1</sub>

Metal infill panel

Replace plexi and metal infill with clear glass.

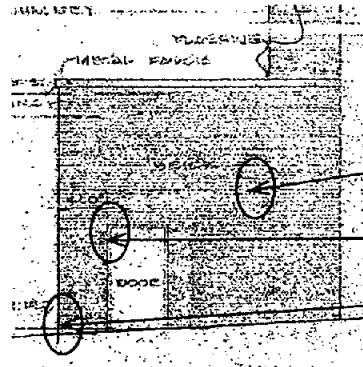
Frame is damaged

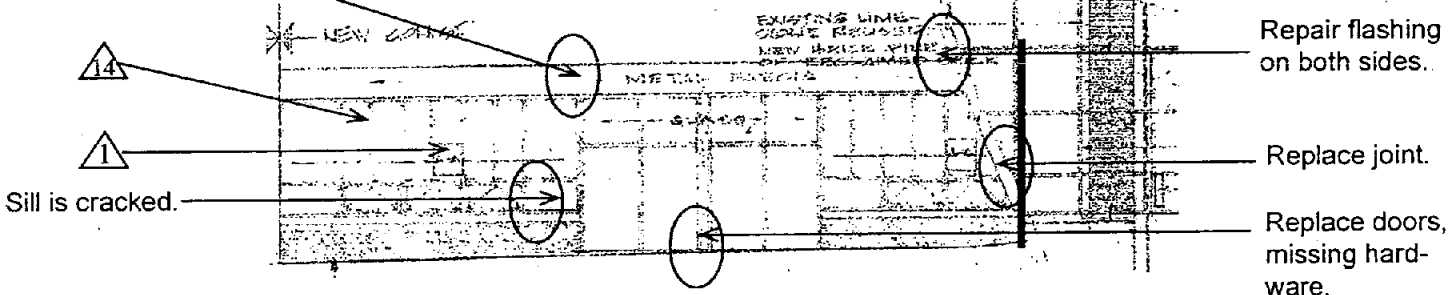
West Elevation / Seg. A<sub>1</sub>

Sill is cracked.

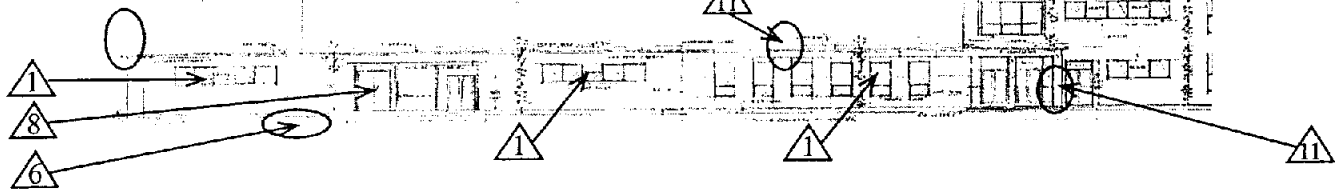
South Elevation / Seg.A<sub>2</sub>

Exposed Re-bar.

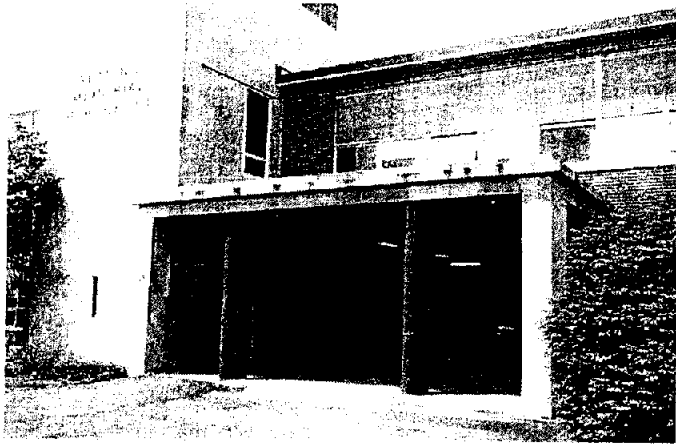
East Elevation / Seg.A<sub>3</sub>

Broken glass block throughout.

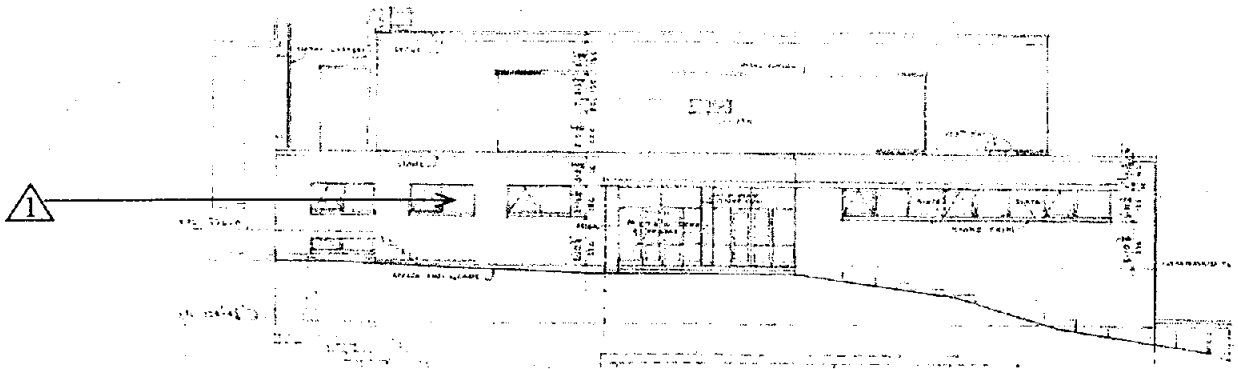
East Elevation / Seg.A<sub>4</sub>

Broken glass block throughout.

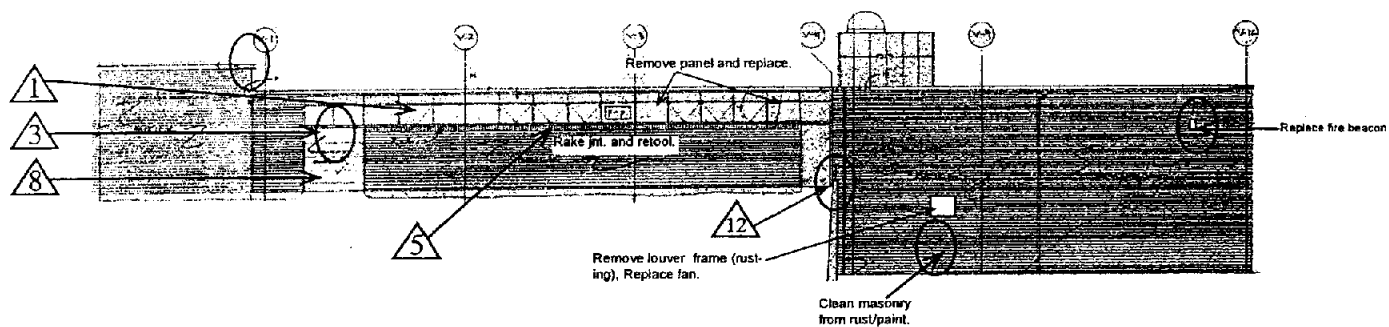
East Elevation / Seg. A<sub>5</sub>

Broken glass block throughout.

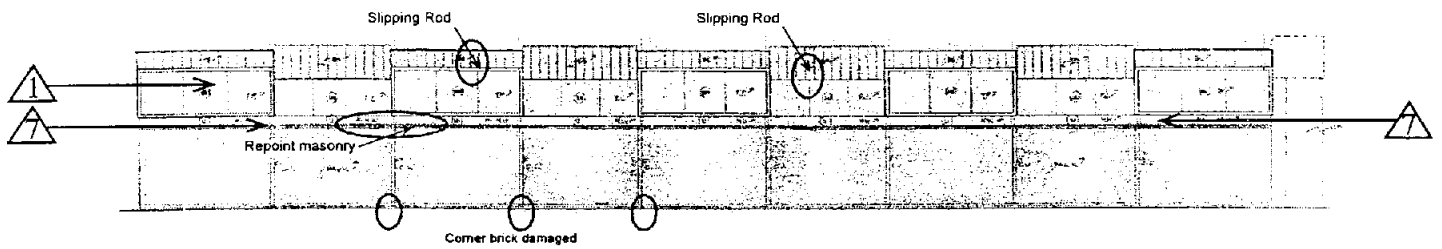
West Elevation / Field House

Broken panels
