INDOOR AIR QUALITY ASSESSMENT

**Reading Memorial High School
62 Oakland Road
Reading, Massachusetts**

Prepared by:
Massachusetts Department of Public Health
Bureau of Environmental Health Assessment
February, 2000

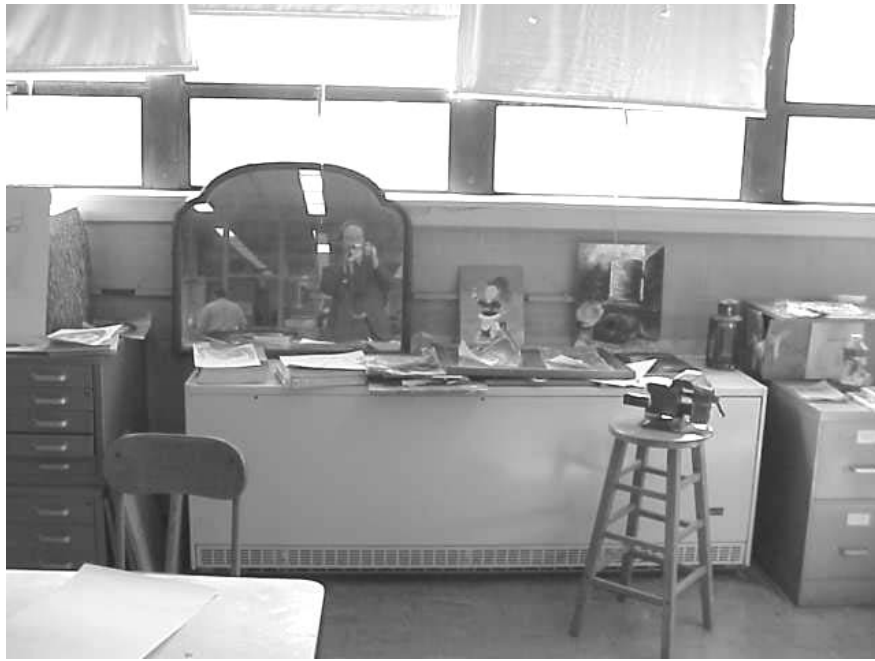
Picture 1

Fresh air in most classrooms is supplied by a unit ventilator (univent) system. (see [Figure 1/Picture 1](#)) These univents were functioning in most classrooms, however, a number were found deactivated (see tables 1-10). In several cases, univents were dismantled and/or reportedly turned off due to excessive noise. Obstructions to airflow, such as books, papers, desks and plants stored on univents were seen in a large number of classrooms. In order for

univents to provide fresh air as designed, fresh air intakes must be unblocked and remain free of obstructions.

Materials Stored on Univent Obstructing Univent Air Diffuser

3. Examine each univent for function. Survey classrooms for univent function to ascertain if an adequate air supply exists for each room. Operate univents while classrooms are occupied. Consider consulting a heating, ventilation and air conditioning (HVAC) engineer concerning the calibration of univent fresh air control dampers school-wide.

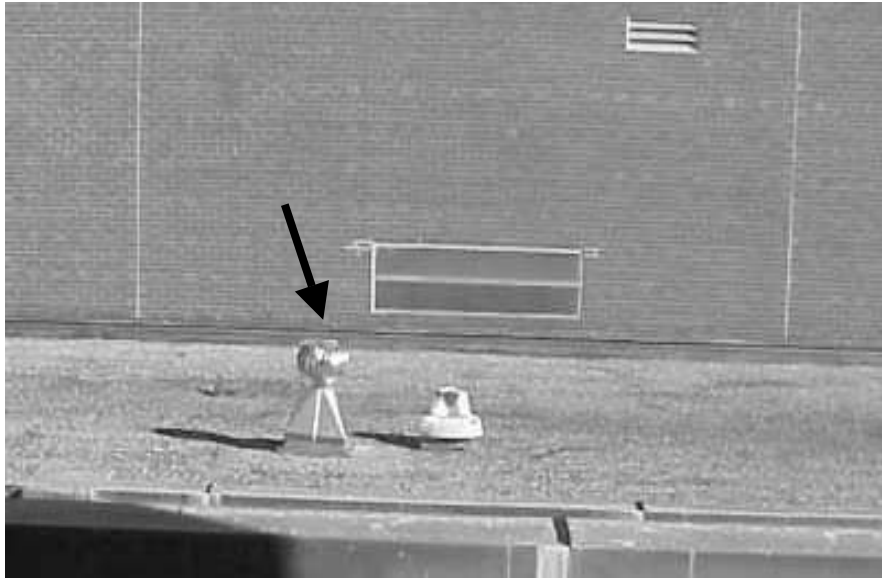
Picture 2

The mechanical exhaust ventilation system is in the process of being replaced with wind driven turbine fans (see Picture 2). As wind drives the turbines, exhaust air is drawn into ductwork. This system functioned as a natural/gravity exhaust system in cold weather with no wind. Warm air rises up exhaust vent ductwork from classrooms and exits the building through rooftop vents. The exhaust system in most classrooms currently consists of ducted, grated wall vents. These exhaust vents were present in rooms throughout most of the building; however, many of the vents were not drawing air or were obstructed by papers, posters, bookcases, furniture and in some cases, open doors. Some classroom exhaust vents are located on walls behind hallway doors. When doors are shut, these vents are clear. In an effort to improve airflow, classroom doors are left open, which blocks exhaust vents and ultimately interferes with the proper function of the system.

Turbine Exhaust Fan on Roof

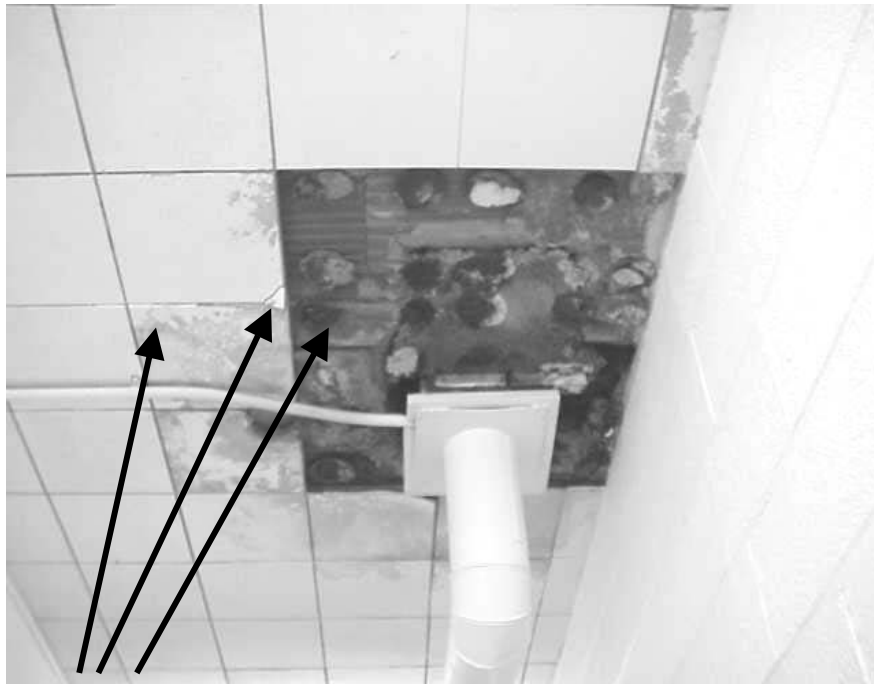
Picture 3

The school has a ceiling tile system that is glued directly to the ceiling (see Picture 3). A number of hallways and classrooms have ceiling tiles which appear to be water-damaged by either water penetration through window frames (see Picture 4) or by leaks around ductwork that penetrates through the roof (see Picture 5). Replacement of these ceiling tiles is difficult, since their removal appears to necessitate the destruction of the tile, which can result in the aerosolization of particulates (see Picture 3). In addition, several classrooms appear to have water-damaged wall plaster. Water-damaged wall plaster and ceiling tiles may provide a medium for mold and mildew growth and should be replaced after a water leak is discovered and repaired. Possible mold growth was observed on ceiling tiles in classrooms A-116, C-207 and C-217.

Missing/Water Damaged Ceiling Tiles, Note that Each Ceiling Tile Is Glued To the Ceiling

1. Water-damaged ceiling tiles should be replaced. These ceiling tiles can be a source of microbial growth and should be removed. Source of water leaks (e.g., window frames and roof) should be identified and repaired. Examine the non-porous surface beneath the removed ceiling tiles and disinfect with an appropriate antimicrobial.
2. Consideration should be given to installing new ductwork at the ceiling level for the wood dust collection system. The design of the current ductwork renders it prone to clogging and is extremely difficult to clean. The installation of exposed ceiling-mounted, ductwork with airtight access doors would provide a system that can be cleaned when clogged. The design of the system should be consistent with recommendations of the American Conference of Governmental Industrial Hygienists (ACGIH) for all wood dust producing equipment (ACGIH, 1998).

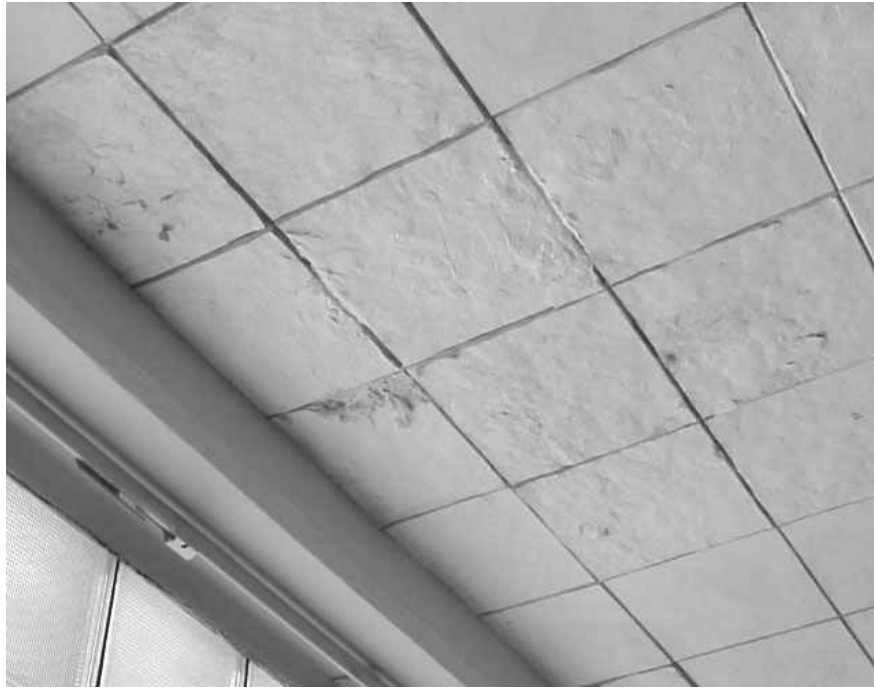
Picture 4

Water Damaged Ceiling Tiles around Window Frames

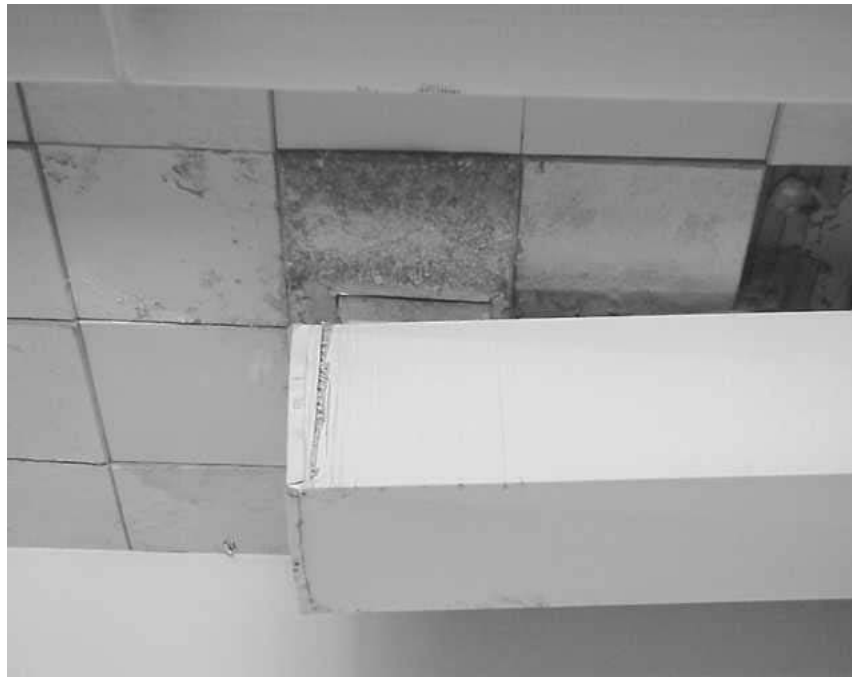
Picture 5

Water Damaged Ceiling Tiles around Ductwork

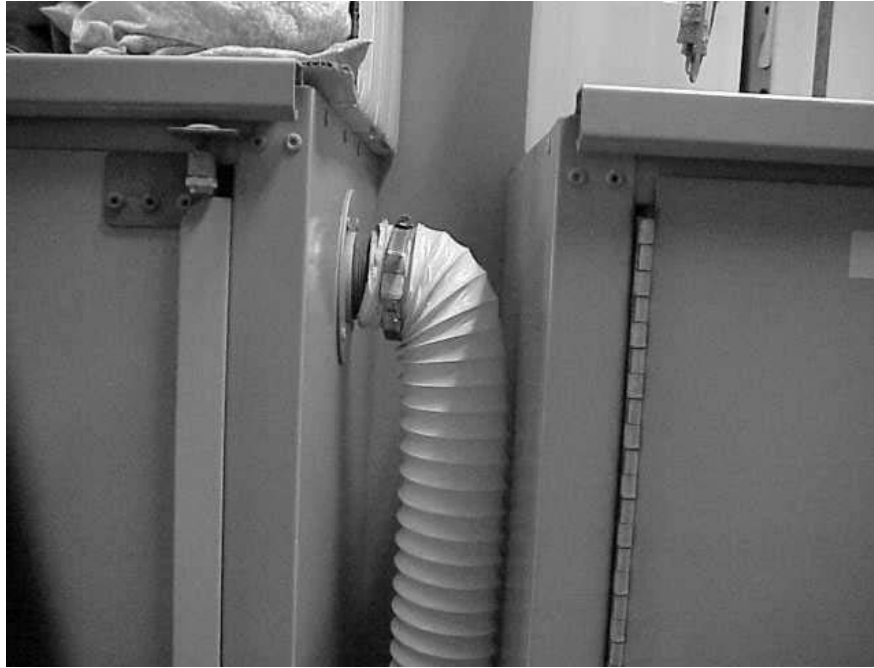
Picture 6

Of note are the conditions under which chemicals are stored in the chemical prep room opposite classroom C-306. The use of plastic flexible hoses as vent ducts (see Pictures 6 through 8) and the potential mixing of volatile organic compounds (VOCs) with acidic materials are not acceptable methods for storing hazardous materials. The connection of these flammables storage cabinets with these vent hoses have, in BEHA's opinion, created conditions that pose an immediate danger to health and safety because of the breach of the integrity of the flameproof storage cabinet as well as the potential mixing of VOCs and strong acids. These concerns were reported to the Reading Fire Department in a letter dated November 24, 1999 (Appendix A). In many instances, improperly stored chemicals in this area pose a fire and safety hazard. Tables 11 through 14 list the chemicals found stored in the science wing which may pose health or

Plastic Flexible Hose Connecting Flameproof Cabinet

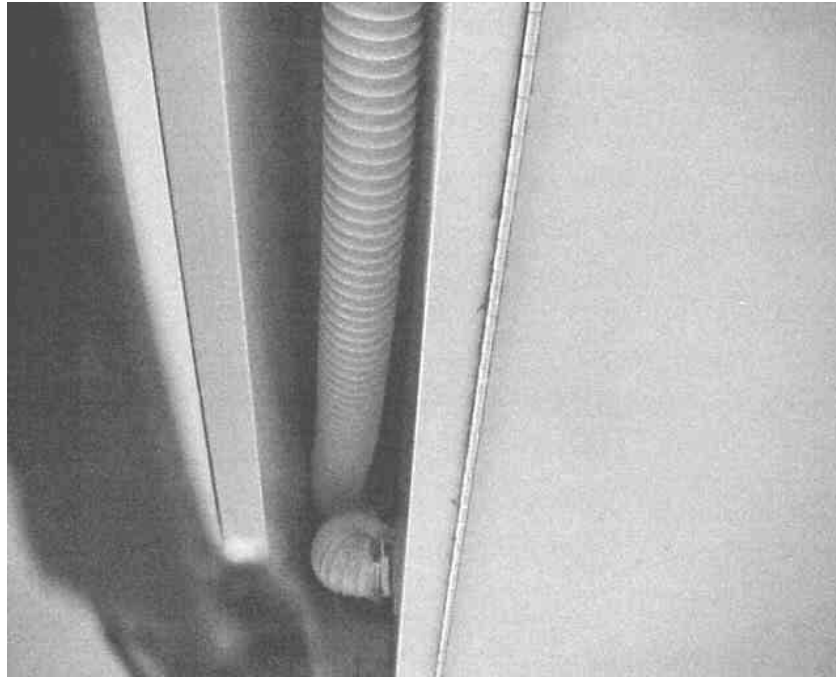
Picture 7

Plastic Flexible Hose Connecting Flameproof Cabinet

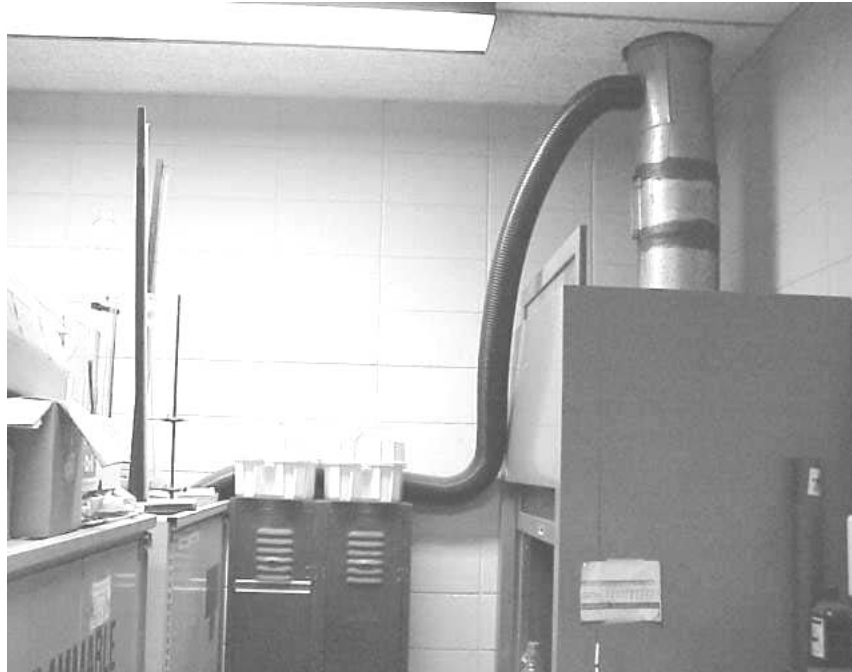
Picture 8

Plastic Flexible Hose Connecting Flameproof Cabinet To Chemical Hood Duct

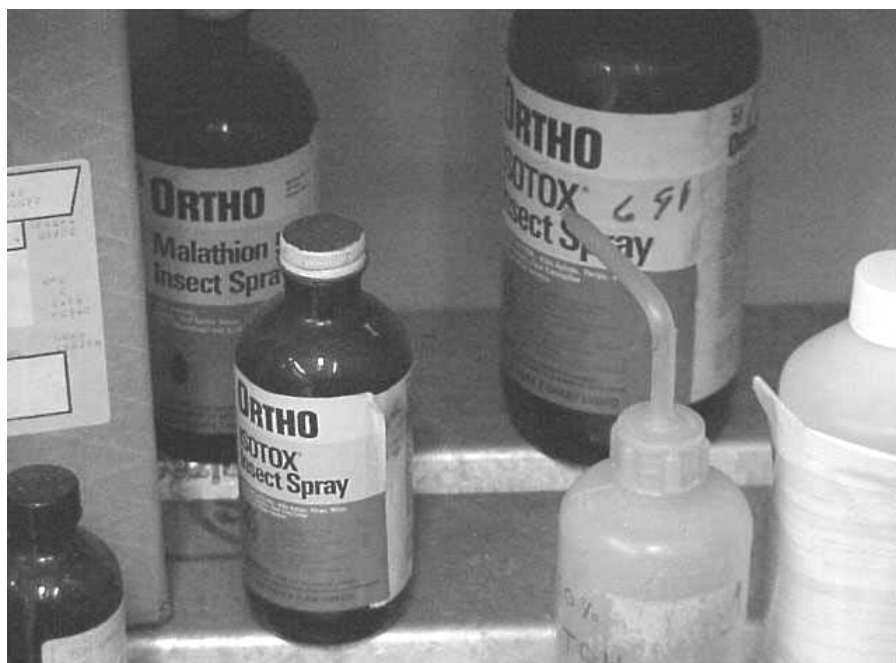
Picture 9

1. In the biology storage area, three containers of restricted use pesticides were stored in the flameproof cabinet (see Picture 9). Malathion is an organophosphate pesticide and Isotox (carbaryl) is a carbamate pesticide. Both materials can cause serious acute health effects upon exposure and can be readily absorbed through the skin on contact (USEPA, 1989). For these reasons, the US Environmental Protection Agency has classified both of these pesticides as restricted use pesticides, which curtails the sale of these materials to the general public and requires that the user of these materials be a licensed restricted use pesticide applicator.

Restricted Use Pesticides Stored in Flammables Cabinet in the Biology Storeroom

6. Remove pesticides from flameproof cabinet and dispose of these materials in a manner consistent with Massachusetts hazardous waste laws.
7. Have a chemical inventory done in all storage areas and classrooms. Discard hazardous materials or empty containers of hazardous materials in a manner consistent with environmental statutes and regulations. Follow proper procedures for storing and securing hazardous materials. Obtain Material Safety Data Sheets (MSDS') for chemicals from manufacturers or suppliers.

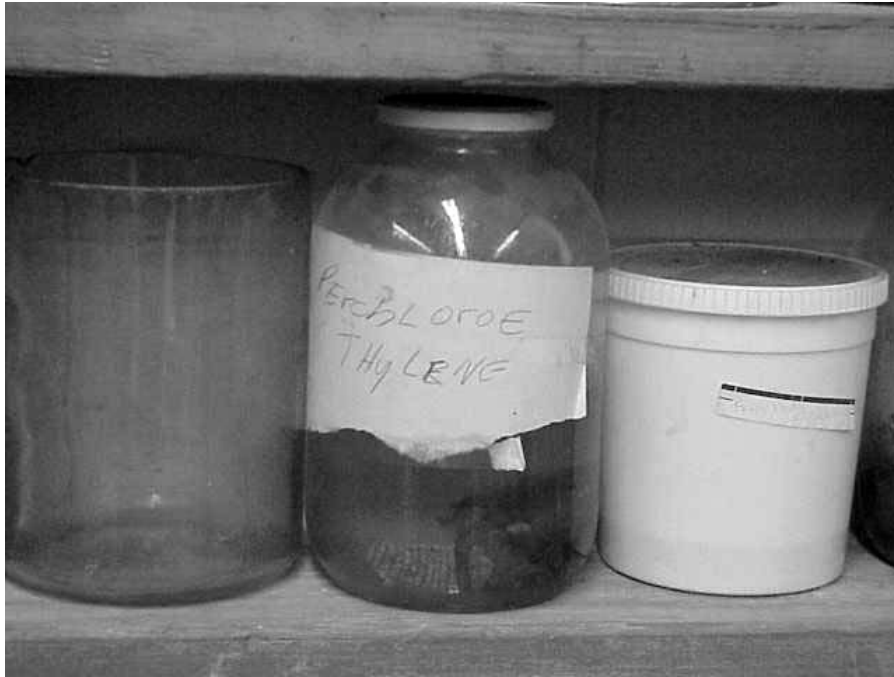
Picture 10

2. The biology storage room also had a container (labeled “perchloroethylene”) that appears to be a former food storage jar (see Picture 10). Perchloroethylene (also known as perc, tetrachloroethylene or PCE) is an organic solvent that can readily evaporate and can cause irritation to the eyes, nose and respiratory tract on exposure. Food containers are not acceptable for storage of PCE, since it may corrode the metal cap, resulting in the release of vapor. It is recommended that this container be disposed of in a manner consistent with Massachusetts hazardous waste disposal laws.

Food Storage Jar Labeled “Perchloroethylene” Stored on Open Shelf in the Biology Storeroom

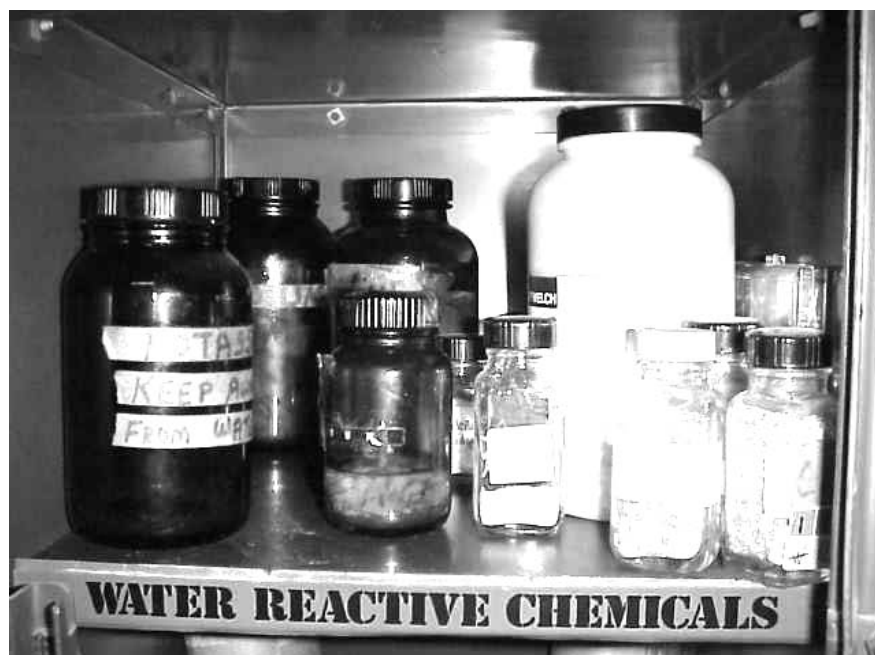
Picture 11

Stored Water Reactive Materials

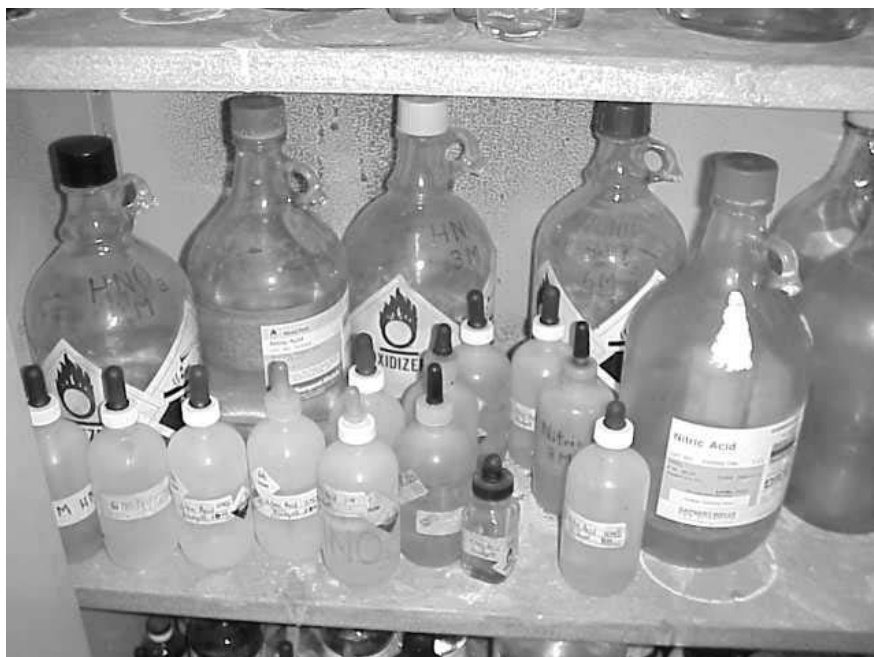
Picture 12

5. The container used for storage of acids is a flameproof cabinet constructed of steel. The interior of the cabinet has become corroded from off-gassing acid vapor from bottles stored in this cabinet (see Picture 12). The storage caps on acid containing bottles have not been secured, as evident by the strong acid odor from the cabinet as well as substantial corrosion to the metal cabinet. In order to prevent metal corrosion, acids should be stored in acid proof cabinets.

**Acids Stored In Steel Flameproof Cabinet,
Note Corrosion of Shelves and Cabinet Walls**

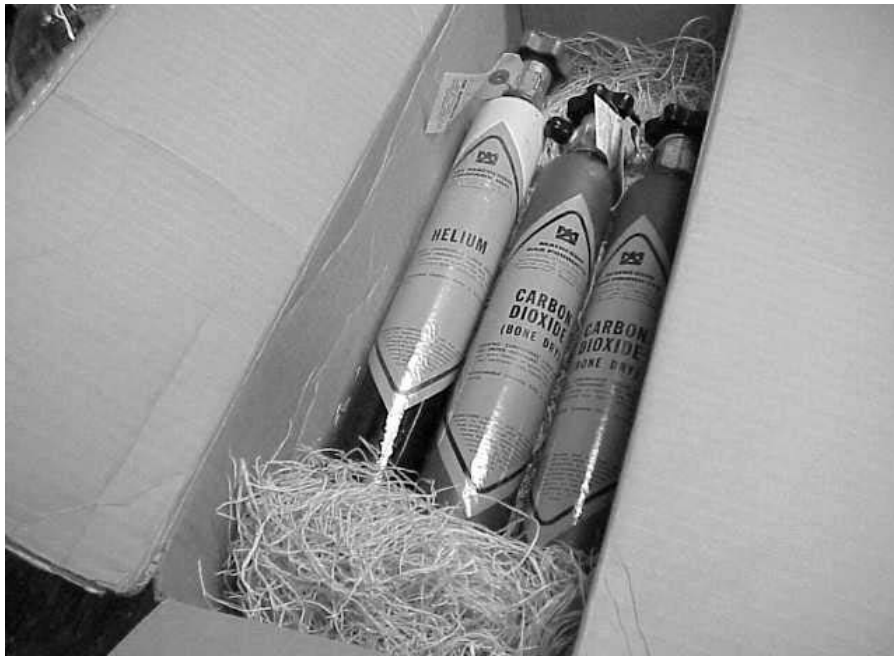
Picture 13

7. Several gas cylinders of carbon dioxide and helium were found stored in a cardboard box on a shelf (see Picture 13). Under both industry regulations and good chemical storage practice standards, cylinders of compressed gas must be fixed to a wall or stand to prevent damage to cylinder valves by tipping (Rose, S. L., 1984). A damaged cylinder valve can cause an immediate and uncontrolled release of the cylinder contents and result in the

- cylinder becoming a projectile. These cylinders must be secured as soon as possible to prevent accidental release and injury.
8. Several containers of elemental mercury were found stored in the organic solvent flameproof cabinet. The containers containing mercury are plastic. Organic solvent vapor can cause distortion and/or breakdown of plastic upon exposure. In addition, elemental mercury stored in plastic bottles is prone to vapor release (FSI, 1999). It is recommended that these materials be removed from this cabinet and stored appropriately.
 9. A corroded metal container of phosphorous red was noted on an open shelf. Phosphorous red should be stored away from heat sources (FSI, 1999). Corrosion can undermine the integrity of a metal container, resulting in the release of the container's contents.

Cylinders Stored In Box on Shelf

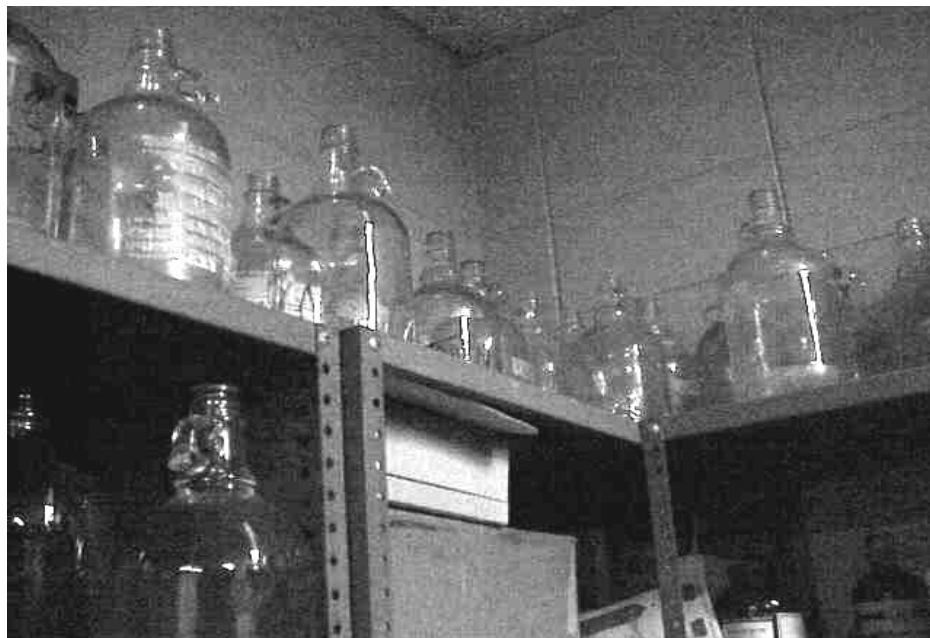
Picture 14

Used, Unstoppered Stock Bottles Stored in Chemistry Prep Room

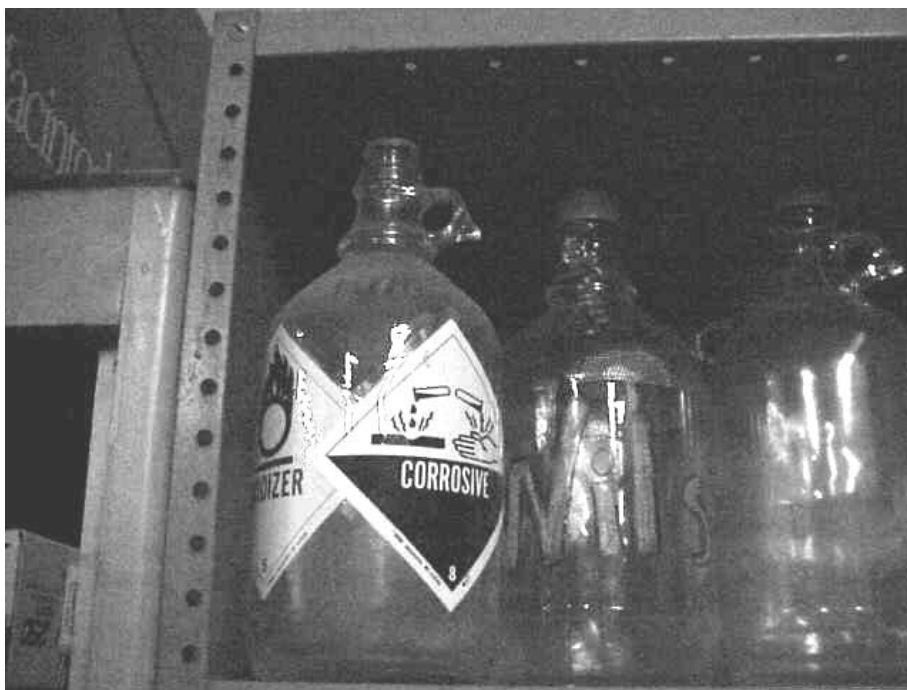
Picture 15

Corrosion can also be a sign of exposure of the container to organic solvent, acid or water vapors.
 10. Open containers of sulfur were stored on a shelf. These containers should be sealed with an appropriate container lid.
 11. A number of empty bottles that formerly contained chemicals are stored in the back of the chemical storeroom on metal shelves (see Picture 14). Among these containers were bottles labeled with DOT placards labeled "corrosive" and "oxidizer" (see Picture 15).

Used, Unstoppered Stock Bottles Stored in Chemistry Prep Room

Each of these containers should be contained, sealed and disposed of in a manner consistent with Massachusetts hazardous waste disposal laws and regulations.
 12. Chemicals are labeled by chemical formula and not name.
 13. Many materials appear to be of extreme age.
 14. Shelves are overloaded with chemicals, so that container labels cannot be seen without moving bottles.

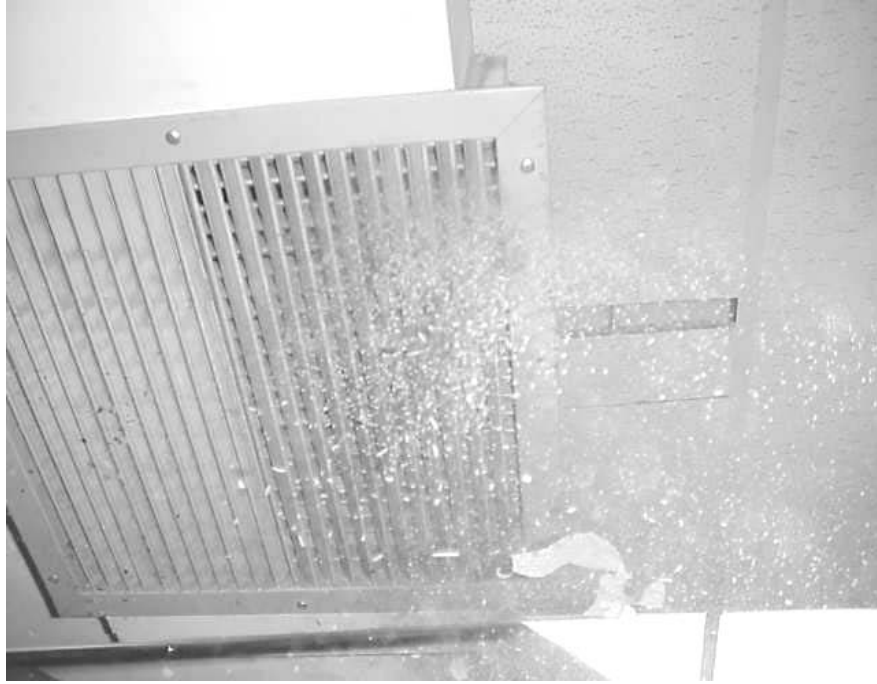
Picture 16

Accumulated Sawdust Knocked from Return Vent by BEHA Inspector in the Wood Shop

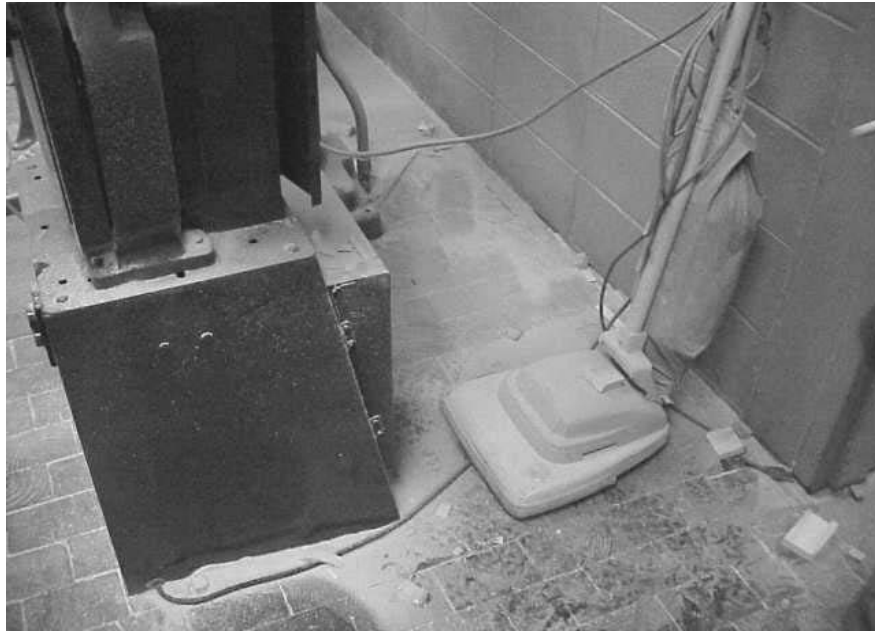
Picture 17

Accumulated Saw Dust in Wood Shop

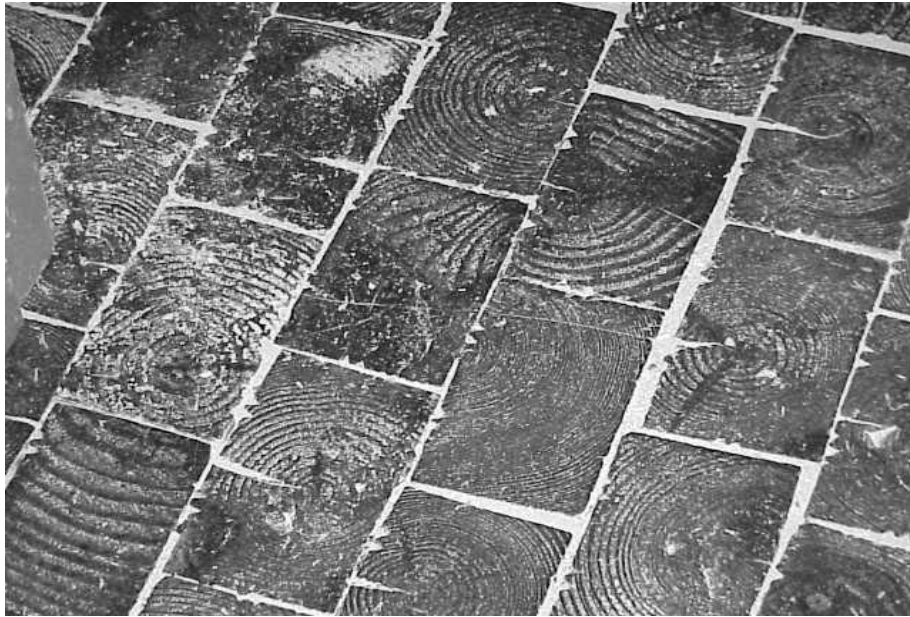
Picture 18

Accumulated Saw Dust in Seams of Floor Tiles in the Wood Shop

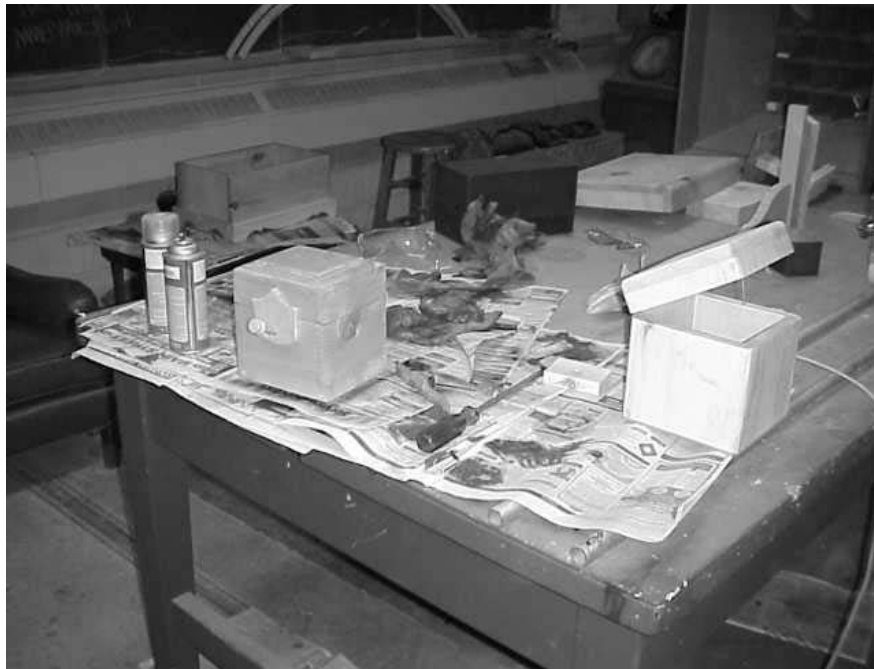
Picture 19

Also noted in the woodshop were spray paint materials in an area without exhaust ventilation (see Picture 19). Spray paint and drying materials should be located in an area with adequate ventilation. The application of spray paint and drying of painted materials should be done in the spray booth located in Art Room 44. Please note that the Art Room 44 spray booth should be equipped with a filter to prevent paint from fouling the fan blades (see Picture 20) and other parts of this equipment. A number of materials are also stored in a plain metal cabinet in the wood shop (see Picture 21). These products are flammable and should be stored in a cabinet which meets the criteria set forth by the National Fire Protection Association (NFPA) (NFPA, 1996). The print shop was found to have flammable materials stored in a metal cabinet. Print shop materials frequently contain VOCs. These products are also flammable, and should be stored in a flameproof cabinet. Several classrooms contained dry erase boards and dry erase board markers. Materials such as dry erase markers and dry erase board cleaners may contain volatile organic compounds (VOCs), such as methyl isobutyl ketone, n-butyl acetate and butyl-cellusolve (Sanford, 1999). These products can all be irritating to the eyes, nose and throat.

Spray Painted Materials with No Local Exhaust Ventilation

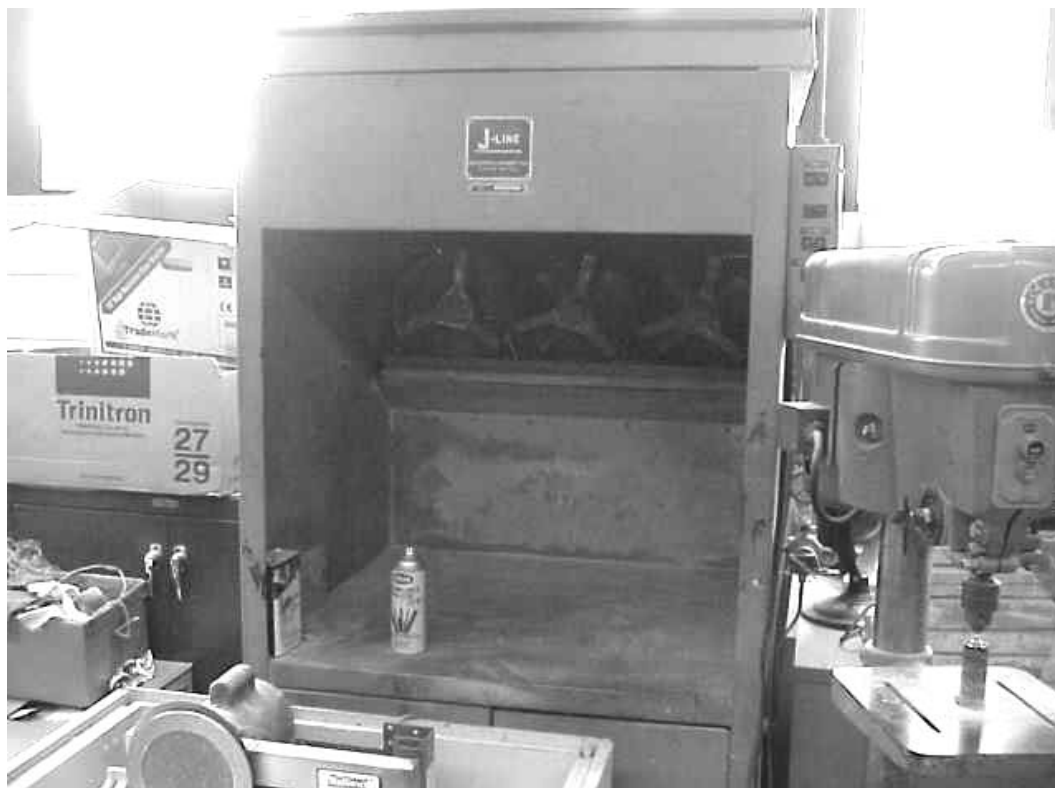
Picture 20

Spray Booth in Art Room A44, Note Fan Blades

3. Extend exhaust vents for the art room kiln and spray booth to prevent entrainment by the art room univent. Consider installing a duct on the top of the wood collector to direct exhaust air from the univent fresh air intake.
4. Repairs (such as removal of ceiling tiles) would be considered a renovation that can release particulates and spores in particular, if the material is moldy. Replacement of ceiling tiles may involve glues that contain VOCs. In order to minimize building occupant exposure to construction materials during renovations, repairs should be done while the building is unoccupied.

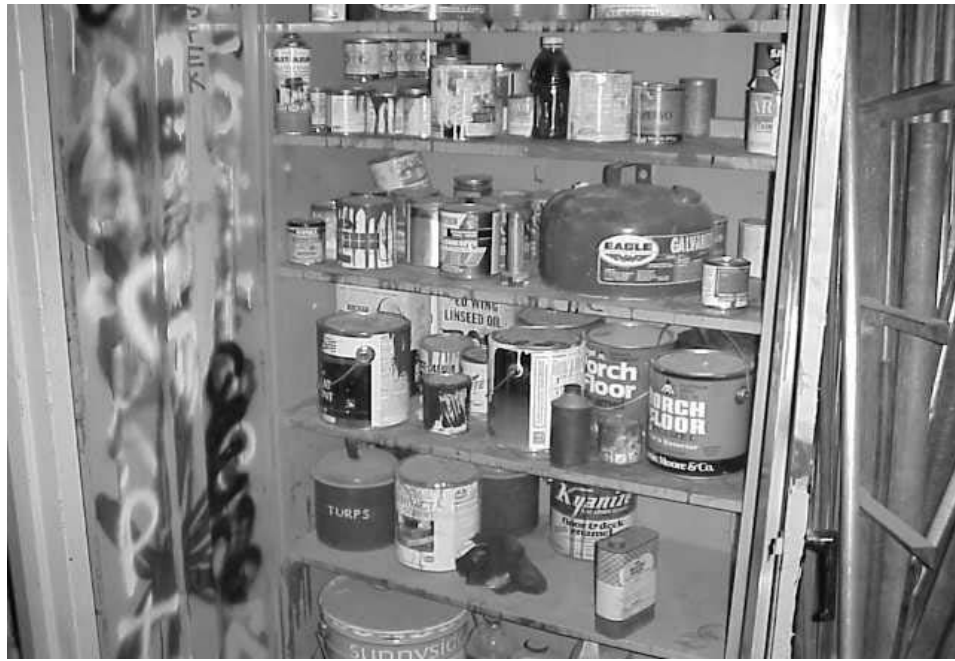
Picture 21

Flammable Materials Stored in Wood Shop

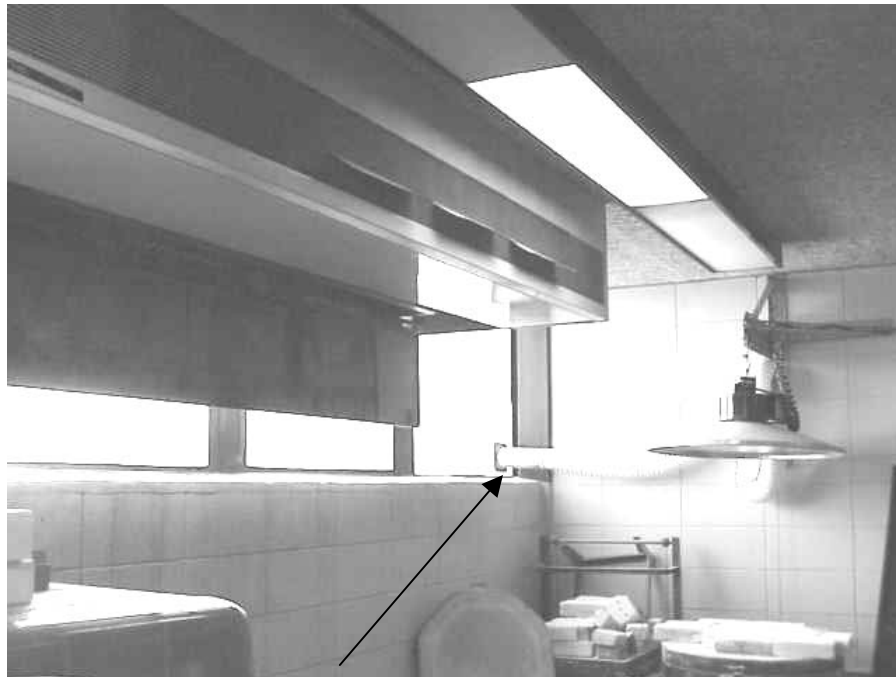
Picture 22

Kiln Exhaust Hose

Kiln In Art Room, Note Location of Ceiling Mounted Univent to Exhaust Vent

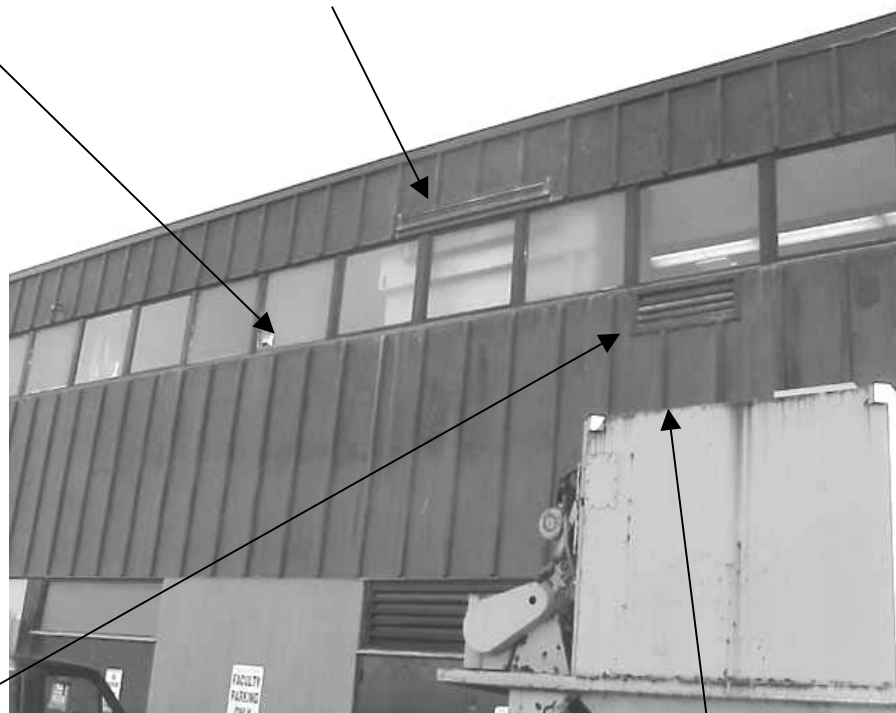
Picture 23

Potential Sources of Pollutants That Can Be Entrained By Art Room Univent Fresh Air Intake

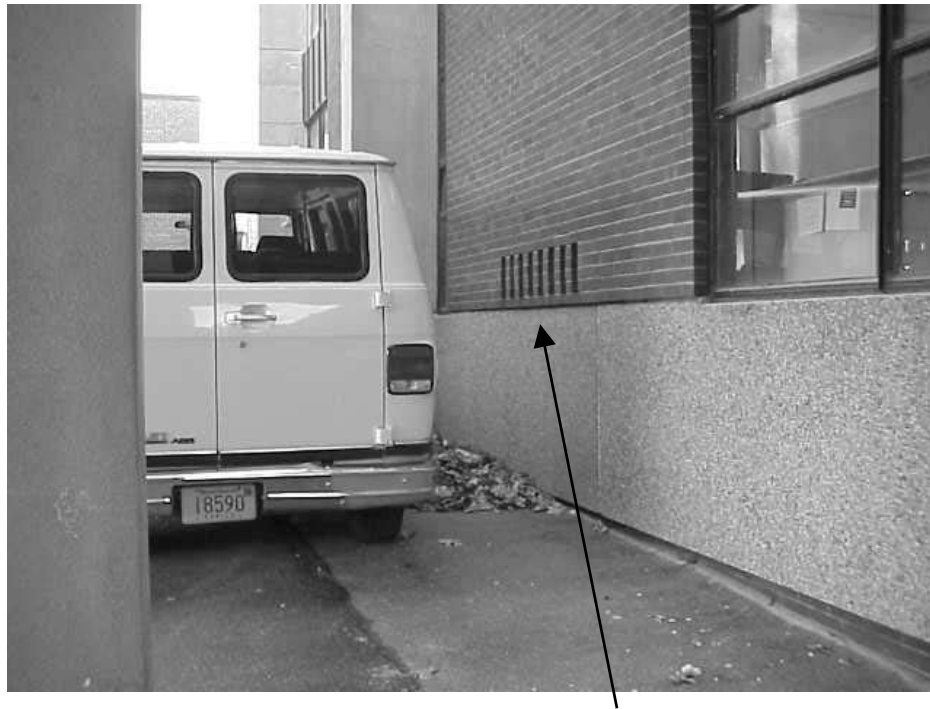
Picture 24

Several motor vehicles were noted parked in close proximity to univent fresh air intakes (see Picture 24). Vehicle exhaust can be entrained through ventilation systems. M.G.L. chapter 90 section 16A prohibits the unnecessary operation of the engine of a motor vehicle for a foreseeable time in excess of five minutes (MGL. 1996).

Van Parked Next to Fresh Air Intake

23. Relocate parking area or consider posting a sign to inform staff/visitors of the close proximity to fresh air intakes and that engines must be shut off after five minutes as required by Massachusetts General Law 90:16A.
24. Prohibit smoking in this building in accordance with Massachusetts law (M.G.L. Chapter 270, Sec. 22). If a designated smoking area is established in this building, provide local exhaust ventilation consistent with recommendations of ASHRAE for smoking lounges (ASHRAE, 1989).
25. Clean chalkboards and chalktrays regularly to prevent the build-up of excessive chalk dust.

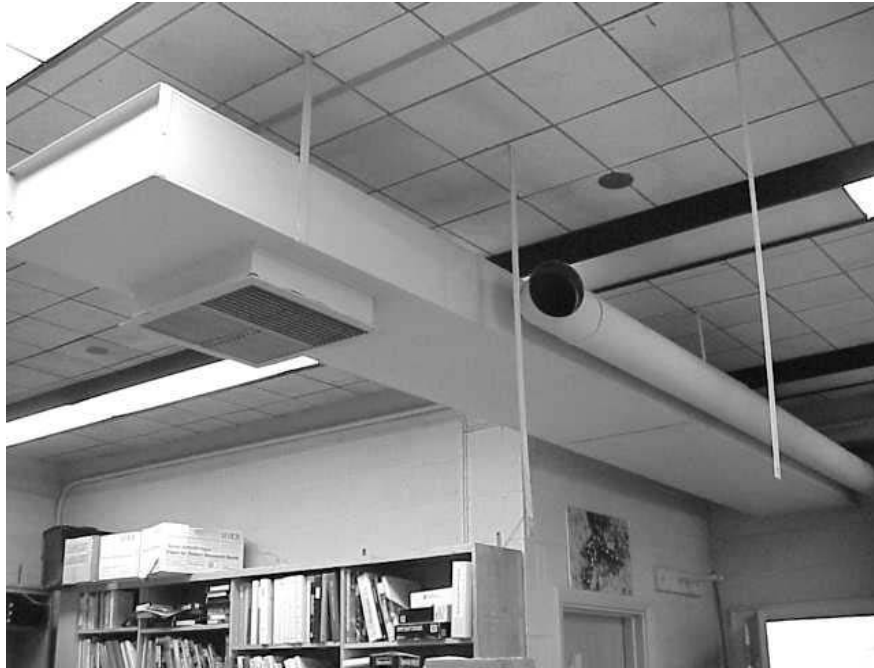
Picture 25

Graphics Room 42 was noted to have unsealed, abandoned ductwork (see Picture 25). This ductwork, if not sealed at its exit-point outside the building, can serve as a source of outside air and moisture. Abandoned ductwork can also accumulate dirt, dust and debris. Abandoned ductwork should be sealed at the outdoor exit point as well as indoors to prevent backdrafting, which can result in the introduction of dirt, dust and moisture into occupied areas from these vents.

Abandoned Ductwork in Graphics

20. Relocate or place tile or rubber matting underneath water cooler in the A-203 office area.
21. Seal abandoned ductwork where found.
22. Seal the drain in the abandoned sink in the weight room.

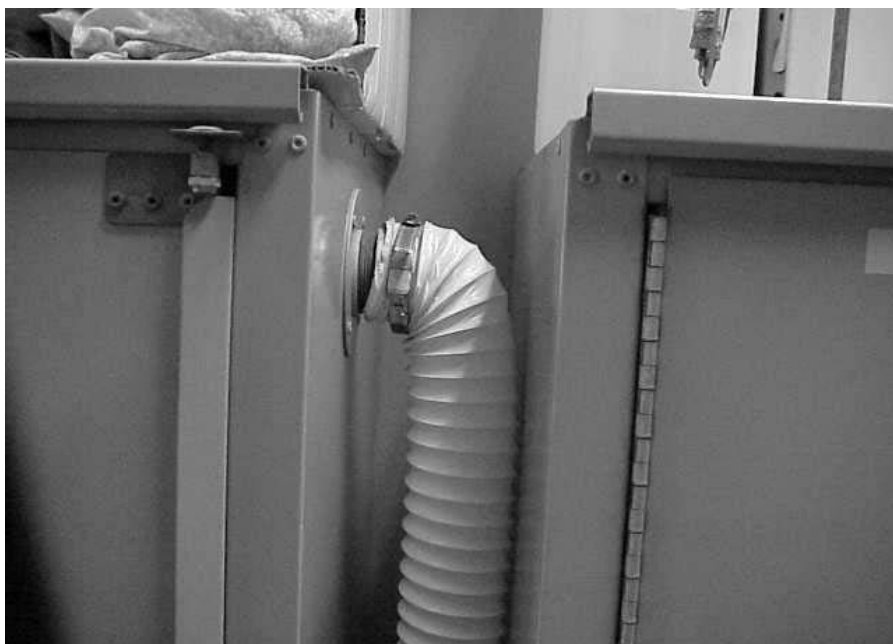
Picture 1

As you probably know, according to the National Fire Protection Association (NFPA), it is recommended that flammables storage cabinets be constructed in a manner to prevent fire from coming in contact with stored chemicals. In addition, it is recommended that if a flammables storage cabinet is connected to a vent system, the vent system should not be constructed in a manner to provide an oxygen source to the interior of the cabinet. The NFPA does not require venting in flammable storage cabinets, however, if venting is done, it must be vented directly outdoors and in a manner not to compromise the specific performance of the cabinet (NFPA, 1996).

**Plastic Flexible Hose Attached to Flammables Storage
Cabinet Containing Volatile Organic Compounds**

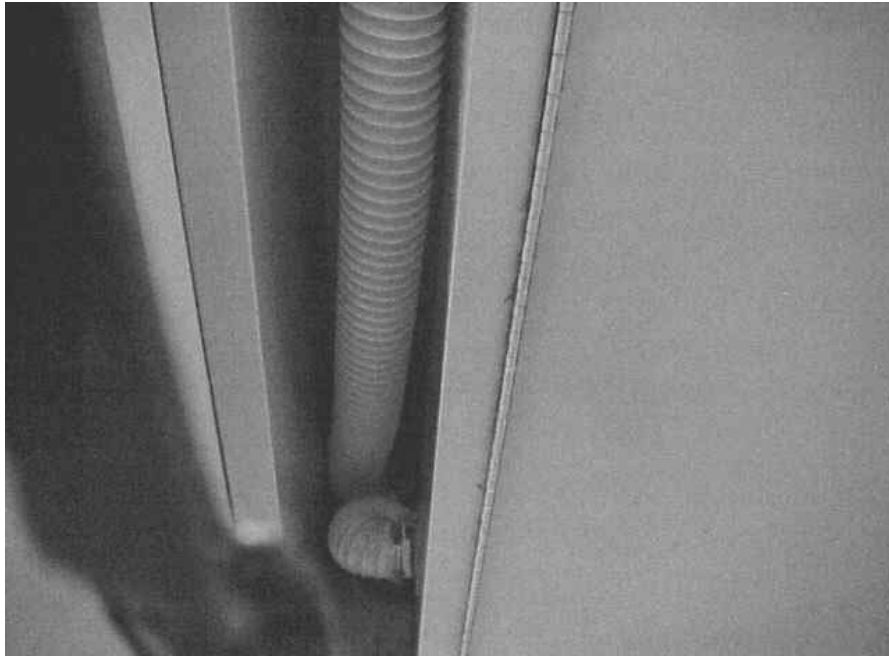
Picture 2

**Lower section of Hose in Depicted in Picture 1 Connected to
Flammables Storage Cabinet Containing Strong Acids**

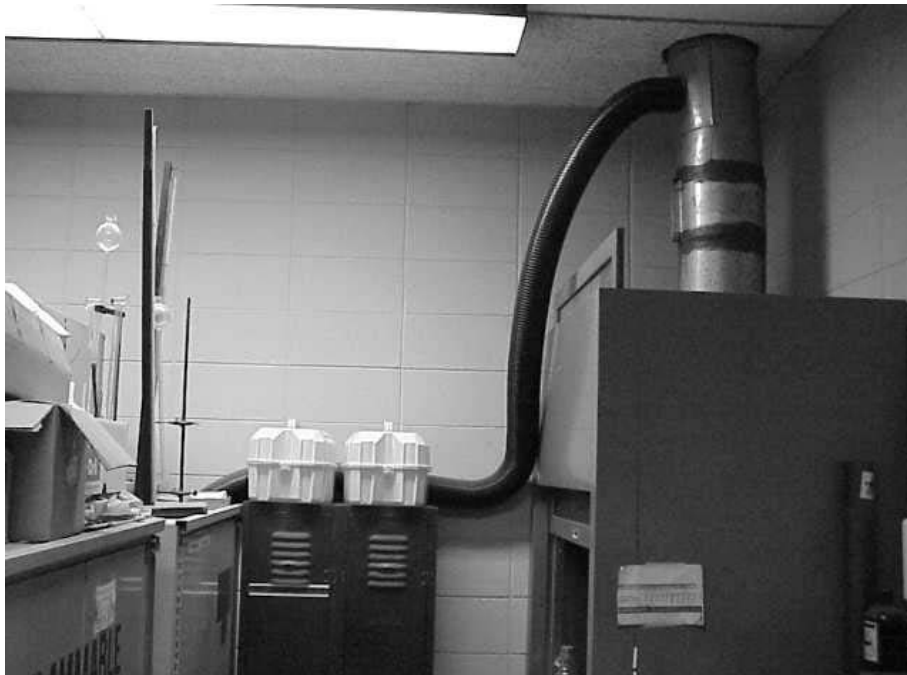
Picture 3

As you know, the Massachusetts Department of Public Health, Bureau of Environmental Health Assessment conducted an indoor air quality assessment at the Reading High School on November 17, 1999. During the course of this assessment (conducted with Jane Fiore of the Reading Board of Health) conditions in the chemical storage area in the first floor of the science wing C at the high school were evaluated. This storeroom contains two flammables storage cabinets. One cabinet contains a number of volatile organic compounds (VOCs); the other contains a number of stored bottles containing strong acids. Of concern is the connection of these cabinets by a flexible plastic hose (see Pictures 1 and 2). The flammables storage cabinet containing the strong acids is connected by a second plastic hose to the vent of the chemical hood (see Picture 3).

Plastic Flexible Hose Connecting Flammables Storage Cabinet to Exhaust Vent Ductwork of the Chemical Hood
