Reading Memorial High School Feasibility Study

*A Study Proposing Physical Improvements
to Support the Educational Goals of the
Town of Reading, Massachusetts*

February 21, 1997

Drummey Rosane Anderson Inc.
Architecture & Interior Design

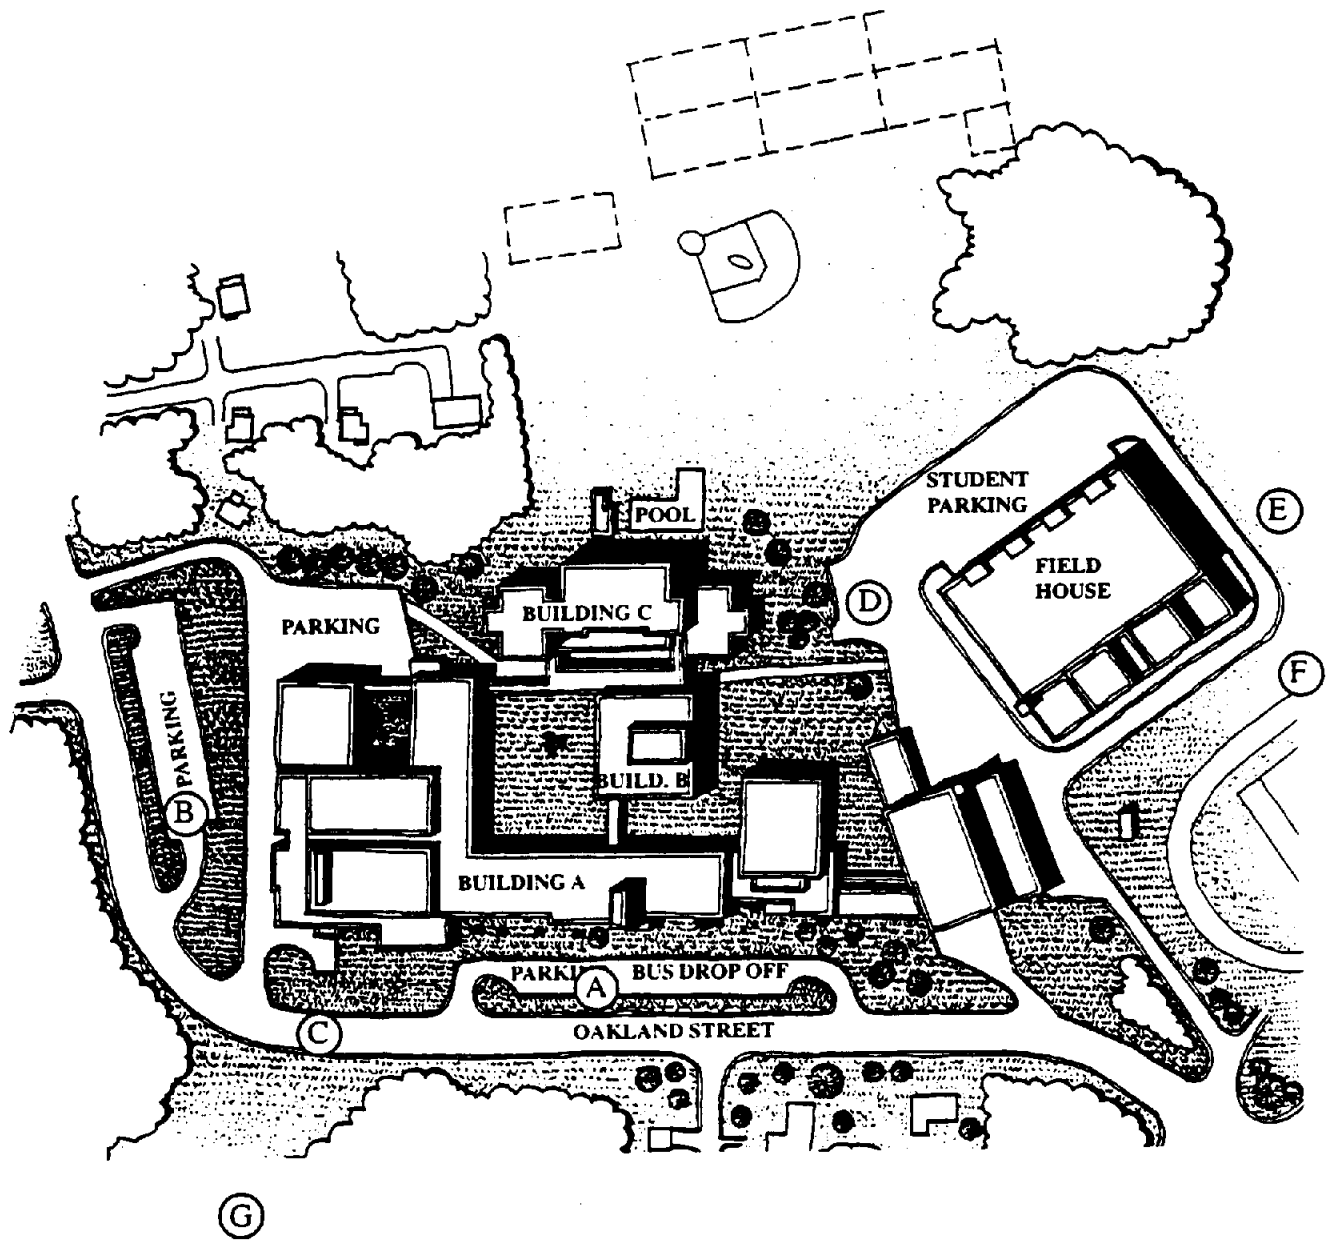
Existing Site Plan

- G. There is a parcel of land owned by the Town east of Oakland Street which has been considered for school use. The site has very steep topography and the sub-surface condition appears to be composed of ledge and large boulders. It would be very costly on a per car basis to develop this land for parking.

- A. Develop a new front entry/drop-off area. Ideally the school bus drop-off zone should be isolated from other vehicular traffic. Improvements at the front entry should include new curbing, sidewalks, better night lighting, site furniture, signage and landscaping; a budget of \$75,000 to \$100,000 should be sufficient to cover these suggested

- B. Redesign and rebuild the 80 car parking area south of the building complex, including new curbing, night lighting, under drainage, and a set of stairs connecting to the school; estimated cost for these improvements is \$100,000 to \$120,000.
