# READING MEMORIAL HIGH SCHOOL REVIEW OF EXISTING CONDITIONS

8 OCTOBER 2002

The Town of Reading School Building Committee, through Flansburgh Associates, Inc., is studying the Reading Memorial High School. In addition to examining the building's capacity and program functions, this study considers the quality and anticipated life of the physical plant. The existing conditions report is the first phase of the overall study; it provides a description and analysis of the building's materials and systems. Athletic fields and site features are also addressed. The report documents ongoing, and anticipated, maintenance/repair concerns. In most cases, this report does not propose a solution. It documents the existing condition. Solutions are considered in proposals made during the ongoing study.

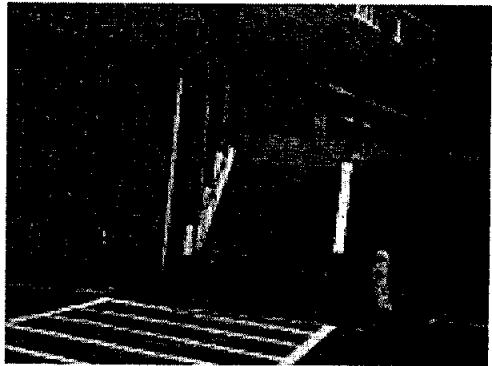
Stairs without handrails

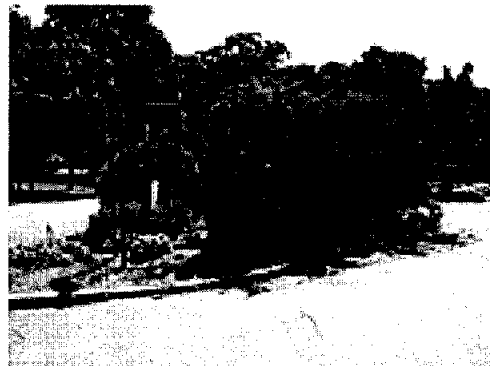
Planting at entry.

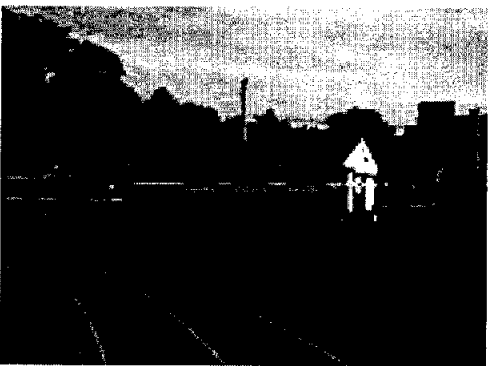
The track and field stadium is bounded by a six-foot perimeter fence that, like the 4' fence around the track, is in very poor condition. The galvanized fabric is rusting and unattractive and several fence posts are damaged and / or heaving due to inadequate footing depths.

- Complete reconstruction of the track and field events area as well as all interior and exterior fencing is required.

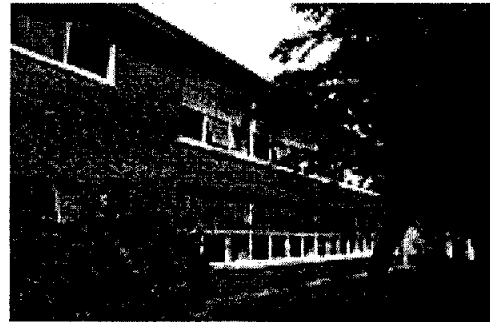
These walls are generally in good condition with minor thermal cracking. Some corner conditions at long brick walls show expansion cracks, which typically occur at the corners in walls of this era without control joints.

While these walls have endured the test of time and remain in generally good condition, they have a very poor R-value of 1.8. This contributes to high-energy usage.

Exterior of Segment A classroom wing.

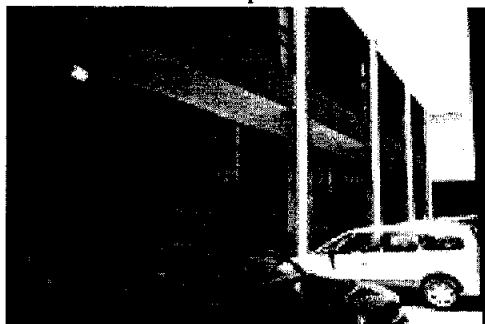
Segment C

Segment B and C structures are more complex in that they have four (4) differing wall systems. The primary system is a 12-inch brick and block wall with 2-inch air space without insulation. This is most prevalent in the Library. The classroom wing is about equally covered with an 8-inch concrete wall with 2 inch glazed tile soaps inside (no air space), and a pre-cast panel wall with 4-inch CMU backup. The fourth wall system works with the window fenestration and is standing seam copper over 3/4-inch plywood on 1 1/2-inch wood frame (no insulation). All original moisture control systems, ie. weeps and flashing, are still functioning. See table on III-3 for wall type 3B R-values.

Further, the continuous brick wall angle supports at floor slabs have popped the masonry joint due to moisture coming out of the flashing rather than through weeps. While it will take several more years, this condition will ultimately lead to failure of the veneer bricks at these shelf angles.

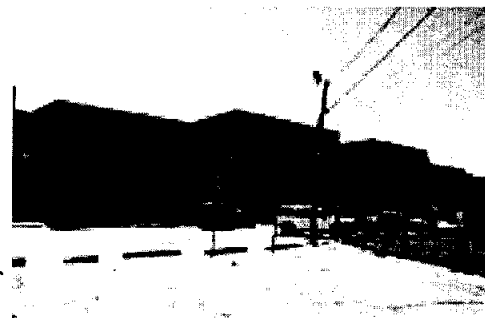
The Field House has three (3) wall systems with the predominant being a 14-inch wall of 8-inch CMU, a 2-inch air space, and a 4-inch brick veneer. The wall to roof form edge transition is mostly seamed copper of 3/4-inch plywood and 4-inch studs and an interior 1-inch panel of fibrous wood (similar to Tectum). The third system is 5-inch pre-cast concrete panel with 4" studs holding the interior fibrous wood panel. With the exception of the minimal fiberglass in stud walls (less than 5%), the field house 2-inch air space added in the 1969 wall systems over the 1952 systems was felt by the industry to better prevent water penetration. It has only minimal effect on thermal transfer, increasing the R-value of these walls to 2.52 – still very inefficient to energy usage and winter comfort.

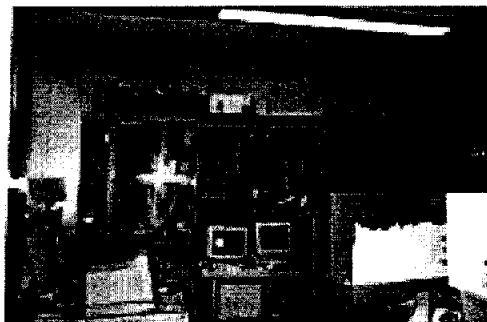
Prep-storage room

dents. The casework is in poor shape. There are missing doors, broken cabinets and the casework is not ADA accessible.

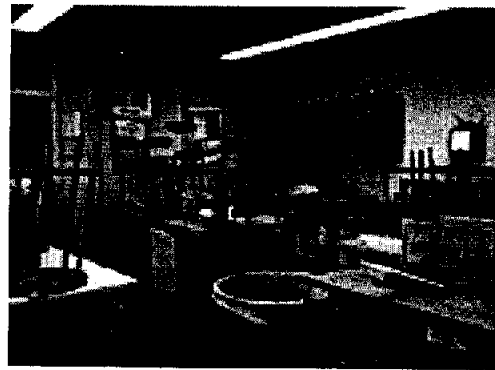
Art Classroom.

- The casework in all of these classrooms is in very poor condition. The countertops are wood and the tables have no knee space and are not accessible. The kiln does not have an enclosed space, which is a dangerous condition, although it is not a code issue. There is very little display space. The office area is very large and is used for storage. The classrooms need more sinks to meet programmatic requirements and more storage space. In general, the art rooms need a great deal more storage space for art projects and more locked storage.
- The Dark room is in very poor shape; it is extremely dirty and there is no table for photography trays. The sink is in poor condition and does not meet the accessibility code.

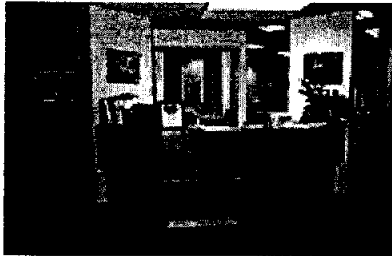
*Superintendent's Office*

The casework in this office has recently been replaced and is in good condition.

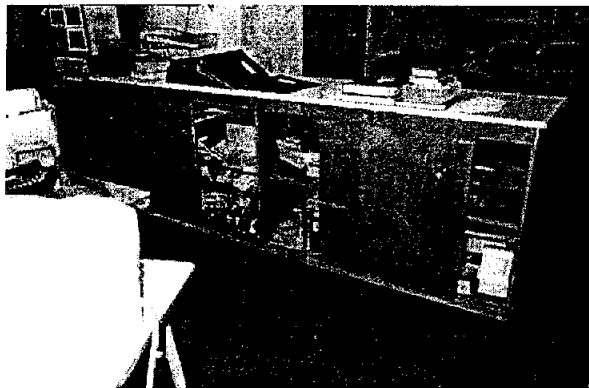
Typical offices counters

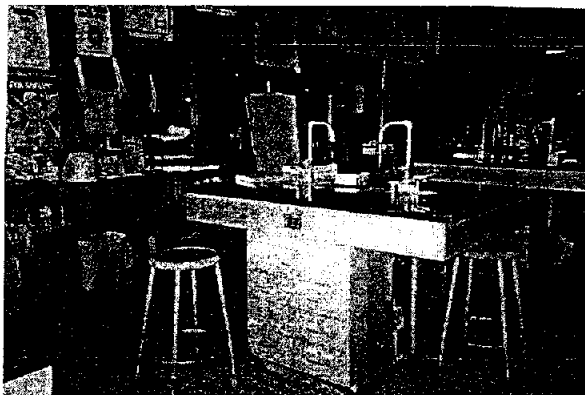
Typical original science tables

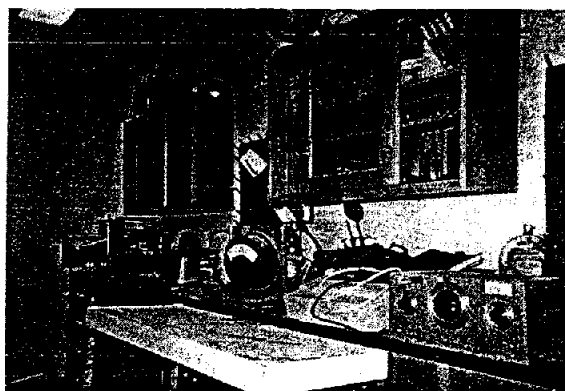
Typical science prep. rooms
